Futuro no. 001 –

documentation and evaluation of preservation needs

Conservation
Historical Interiors
Bachelor's Thesis
28.5.2010

Anna-Maija Kuitunen

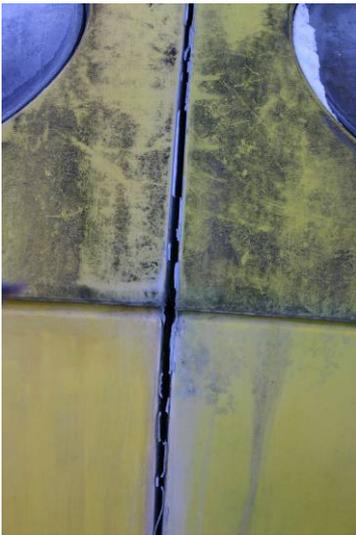
There are many gaps without any proper gaskets so these are the places where the water may have entered the structure (fig. 88.). There are two caps on the roof that protect the air outlets from rainwater. Both of them have fallen down and water may well enter the structure. Both caps are now inside the Futuro house (fig. 89.). The house has been tried to cover with a protective plastic sheet that already shows already in the picture taken for the *Futuro - Tomorrow's House from Yesterday*, the first edition of which was made in 2002. The plastic cover sheet is still hanging loosely on the house having not much longer protective effect.

Figure 88. Many gaskets are cracked.

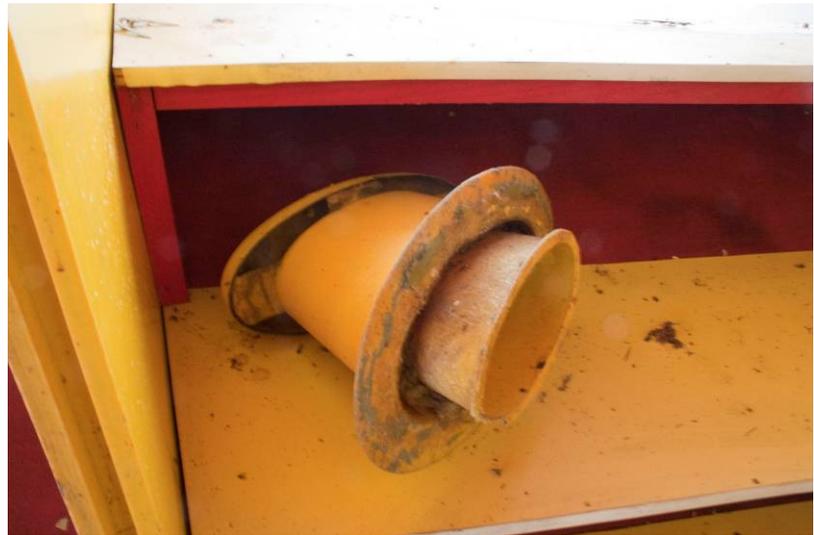
Figure 89. Protective cap of the air outlet has fallen down from the roof.

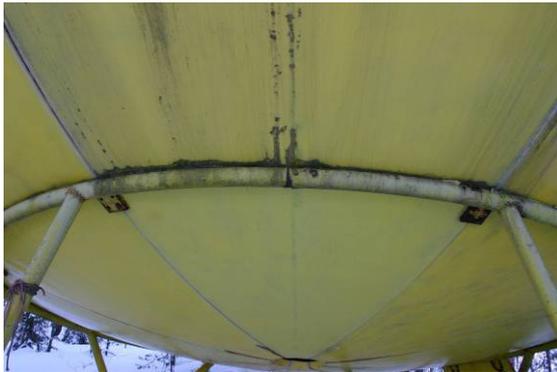
Figure 90. Steel ring is dirty and paint layer is coming off.

The surface of the steel legs is very dirty in some places (fig. 90.). The paint layer of the steel legs is coming off at some parts and rusted steel is shown (fig. 91.). Some screws are missing, which fasten the body of the house to the steel ring. Over one third of them are missing. The metal of the screws might have corroded and the screws may have fallen down. It is also possible that the steel legs have moved so much that the screws have loosened and fallen down. Detailed places of the damages are illustrated in the damage mapping (app. 1–3).

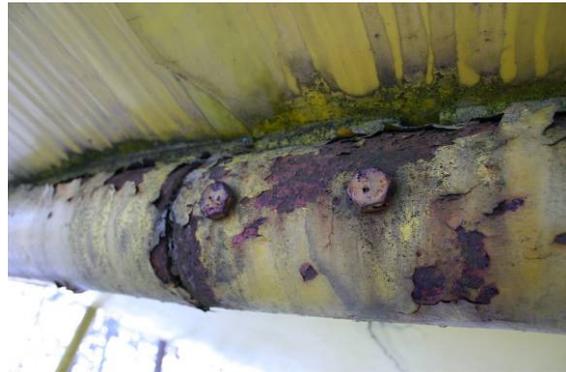
Figure 91. Corroded steel ring.

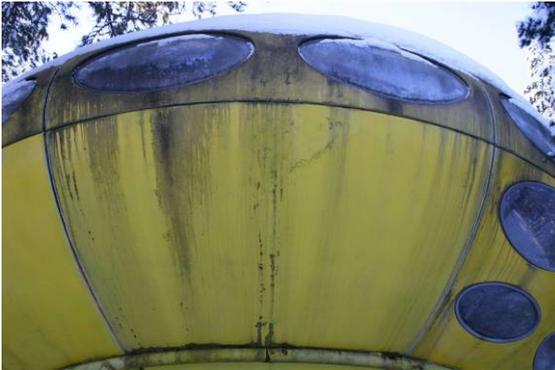
The exterior gel-coat surface has become very dirty especially in the areas around the windows (fig. 92.). The exterior surface has been exposed to the weathering and UV radiation which have led to the fact that the smooth and glossy gel-coat finishing has begun to wear off and porous surface has begun to gather black deposit (fig. 94. & 96.). Some micro-organism like mosses is growing on the surface (fig. 93.).

Figure 92. Dirt is concentrated mainly around the windows.

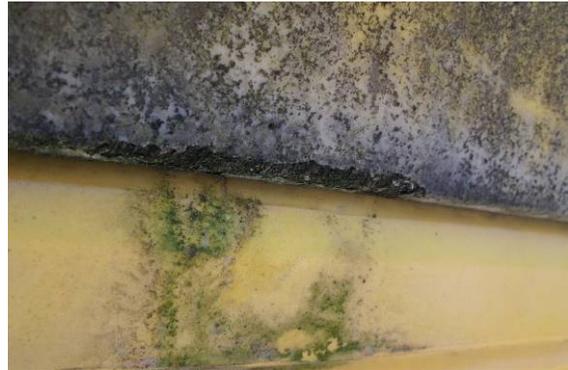
Figure 93. The edge of the small shelter has worn away. Some micro-organism was detected.

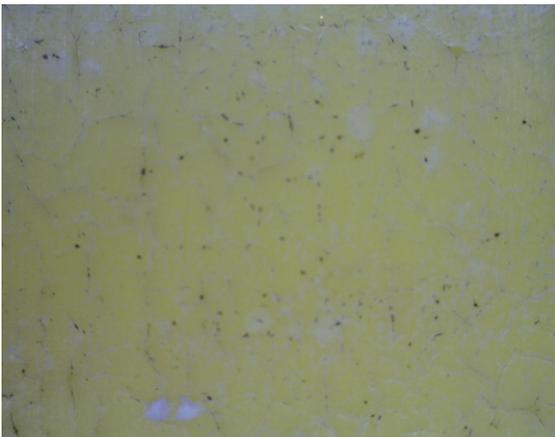
Figure 94. (left) The exterior wall surface has lost its gloss and become non-translucent. Fine cracks shows. (60-fold magnification)

Waentig writes on her book called *Plastics in Art* that "GRP plastic loses its shine relatively quickly, and in the course of time the surface becomes matt and cracks. A small cracks allows moisture to penetrate, which in turn weakens the adhesion of the resin to the glass and in extreme cases the glass fibres, pigments or filler are exposed." (Waentig 2008, 262)

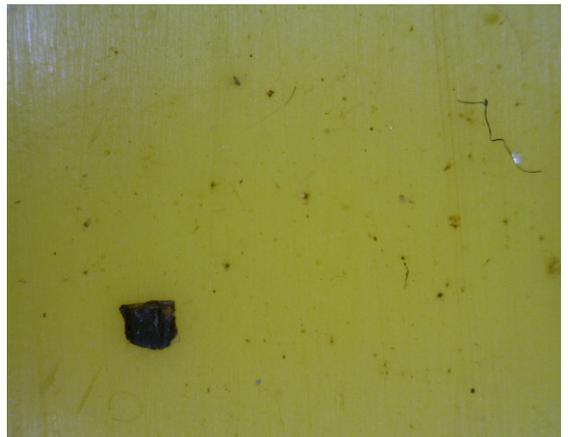
Figure 95. (right) The surface of the partition wall element is still glossy and in good condition. Only some small particles of dirt are present. (60-fold magnification)

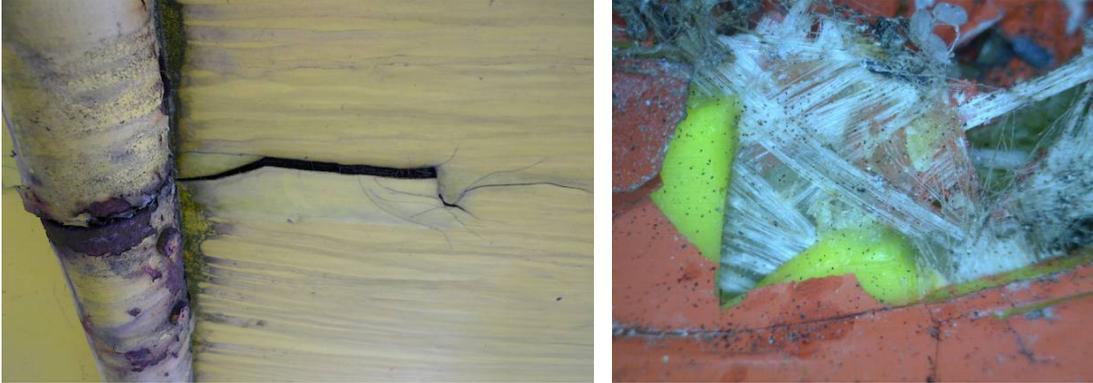
The crack has become larger in the case of the entrance hall wall, around the windows as it can be seen in figure 97. The red paint layer has come off and the yellow gel-coat is exposed. These are the areas where the water and ice have stayed longer periods causing mechanical stress by entering the cracks deeper.

Figure 96. (left) Crack on the gel-coat on the bottom of the house.

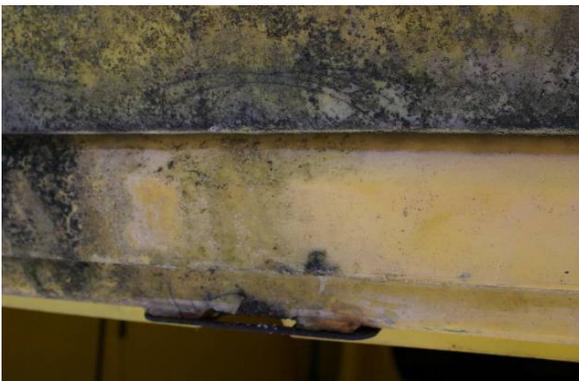
Some cracks were detected above the entrance door. They are most likely caused by mechanical stress (fig. 98. & 99.). Outside, slightly above the level of the steel ring, between the two rooms, the toilet and the kitchenette there is quite a large fracture in the gel-coat (fig. 96.). It has most likely been caused by a mechanical impact that may have come from outside. It can be so that the surface has got a strong impact from inside during the assembly of the partition wall and fixtures of the toilet and kitchenette. It is also possible that the fracture in the gel-coat finishing has been caused by water that has entered the structure.

Figure 98. Some cracks are visible above the door.

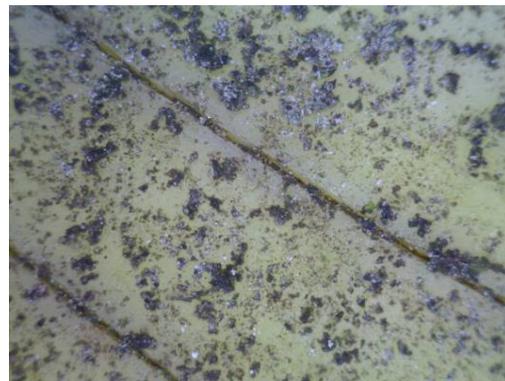
Figure 99. Cracks and deposits above the entrance door. (200-fold magnification)

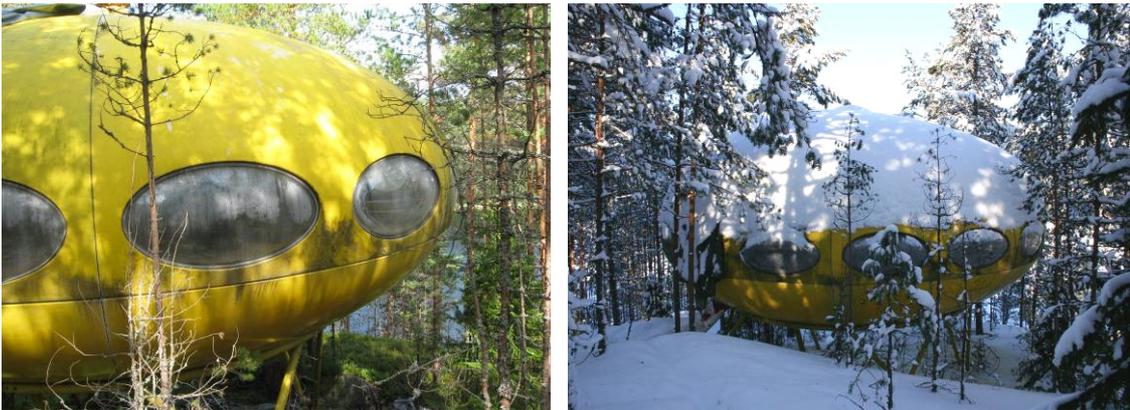
The top of the house surface was observed by a photograph taken in September 2009 shows part of the roof (fig. 100.). By the time of survey a record amount of snow covered the roof (fig. 101.). The condition of the Geissler Futuro's roof reported to be very porous and chalking in the Tim Bechthold's paper from the conference held at the London's Victoria & Albert Museum in 2007 titled *Plastics - Looking at the Future and Learning from the Past* (Bechthold 2008, 32). The photograph gives a similar impression of Futuro no. 001 roof condition. The roof top is exposed to the sunlight, rainwater and heavy snow depending on the time of year.

Figure 100. (left) A photograph taken in September 2009 shows the roof condition.
Figure 101. (right) Snow covers the roof.

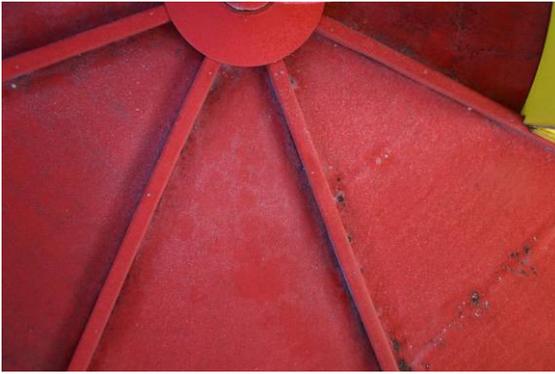
The exterior wall surface from the inside is covered by some black deposit (fig. 102. & 104.). A closer look reveals that the dirt has settled in the small hollows between the exposed glass fibres that can be seen in figure 105. The small dirt particles seem to be loose and easily removed mechanically. At some areas the deposit consists also of moss and algae growth. The dirt on the interior wall surface collects humidity and offers a good ground for micro-organism growth now and in the future if the dirt is not removed. The strongest moss growth was detected under the windows on some of the bolted edges where the roof and the floor elements encounter (fig. 107.). On these edges lay also dead insects. Only a few small areas of mechanical damages on the wall surfaces were detected. In these areas fine cracks are formed and the cracks have turned dark probably due to the moist and dirt penetration inside the cracks.

Figure 102. Some elevated areas on the living room ceiling and black deposit.

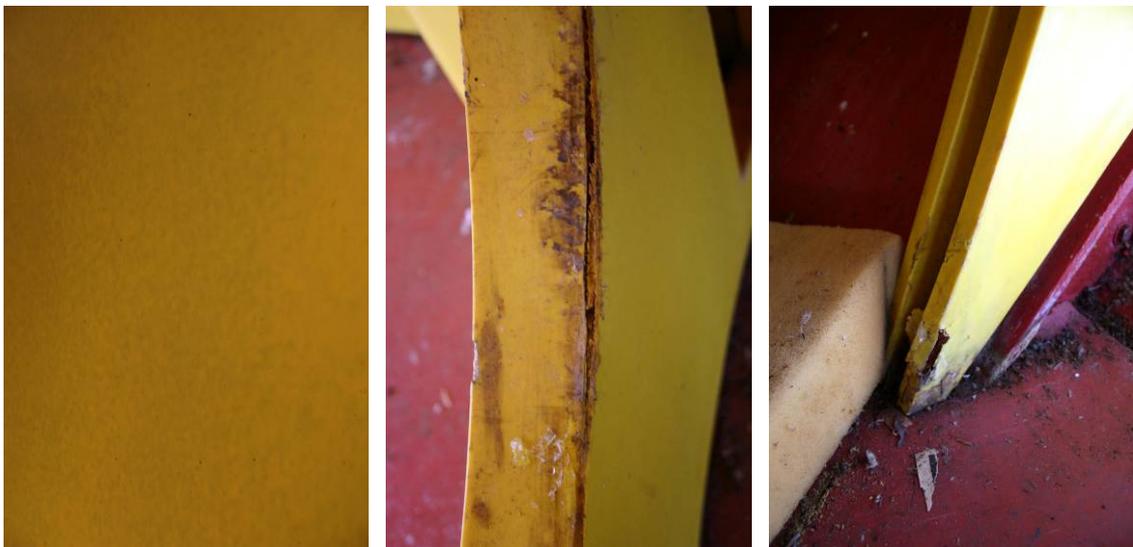
Figure 108. (left) Gel-coat layer is becoming thinner.

Figure 110. (right) Fracture in the kitchenette partition wall.

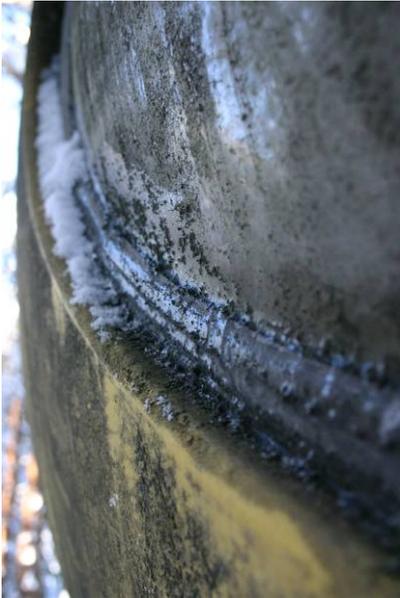
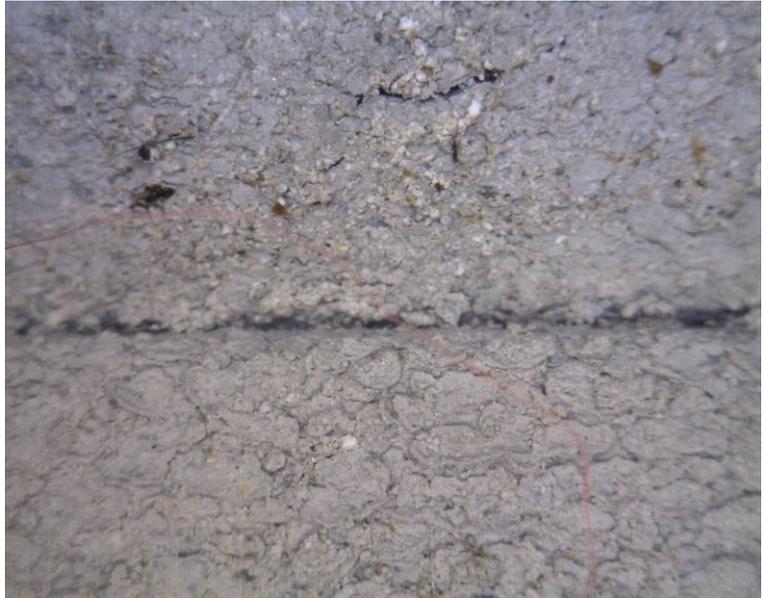
The rubber seals have all become uneven and started a deformation process as it can be seen in the 60 fold magnified figure 112. The gaskets are exposed to UV radiation as well as to water and ice that cause a huge stress to the rubber material. The window seals have canopies in the middle for rubber bands. The rubber band has snapped almost in every window and they are not keeping the window panes tightly in their places (fig. 113.). Also the fire-safety window seals have snapped even though their seals are different. This has already led to the fact that a couple of window panes have fallen down. One fallen inner window pane is from a small fire safety window in the living room and another is an inner window pane from one of the two windows in the dressing room (fig. 114.). In fact there is a third loose window pane in the living room that is probably going to fall down next. All the fallen window panes are stored in the dressing room of the Futuro house.

Figure 111. Ice on the window seal. Figure 112. Window seal surface has altered from smooth to uneven. (60-fold magnification)

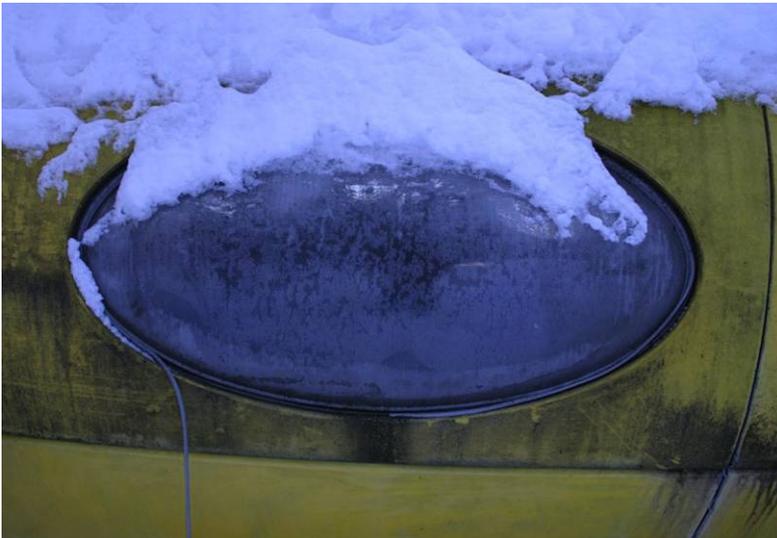
Figure 113. Window seal is loose.

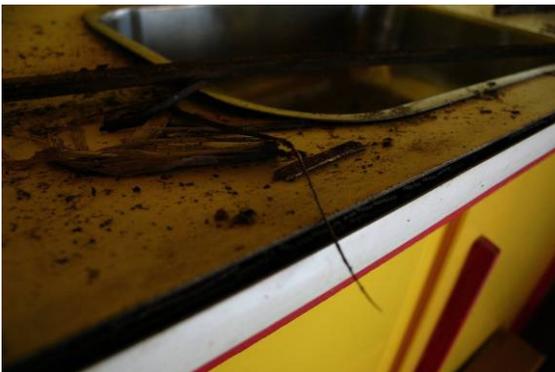
Figure 115. Loose edging strip.

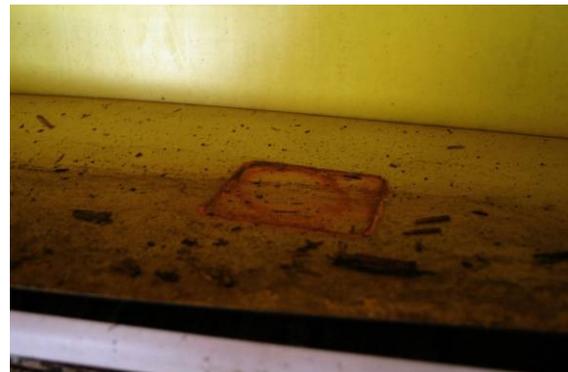
Figure 116. Rusty stains on the surface of the shelf.

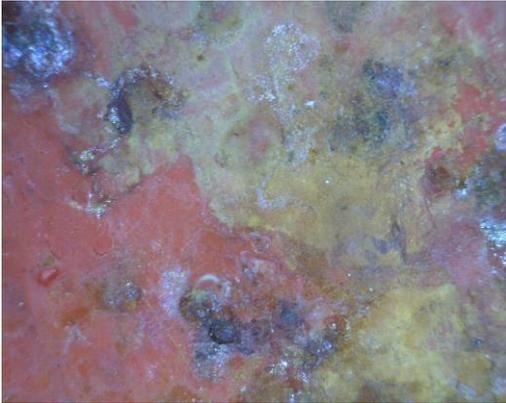
Figure 117. The yellow paint layer under the red paint layer of the steel hood of the fireplace. (200-fold magnification)

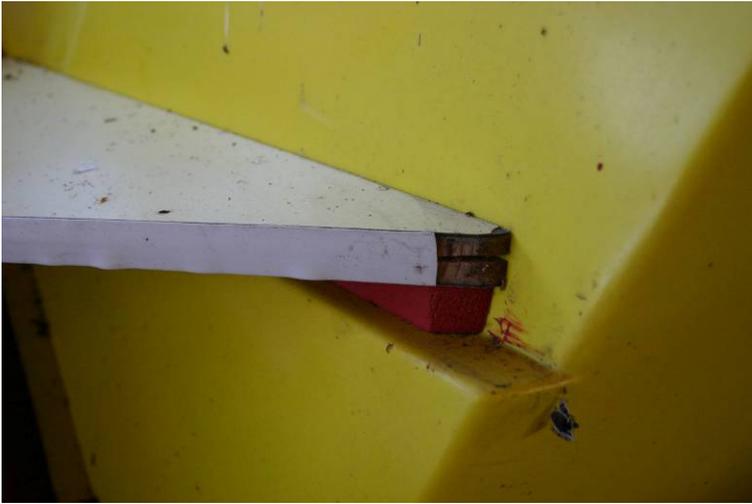
Figure 120. Missing part of the edging strip.

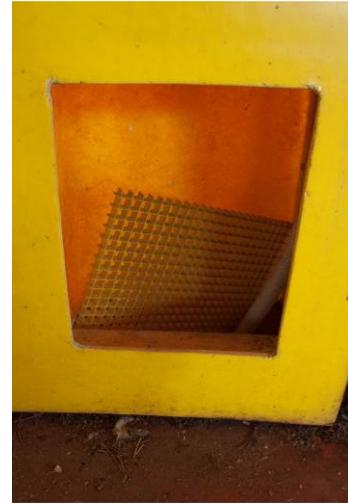
Figure 121. Loose grating on the ventilation hole.
