Critical points to recognize when preparing M/V Prima Ballerina for cargo hold inspection

Degree Thesis for Bachelor Maritime Management

Title: Critical points to recognize when preparing M/V Prima Ballerina for cargo hold inspection

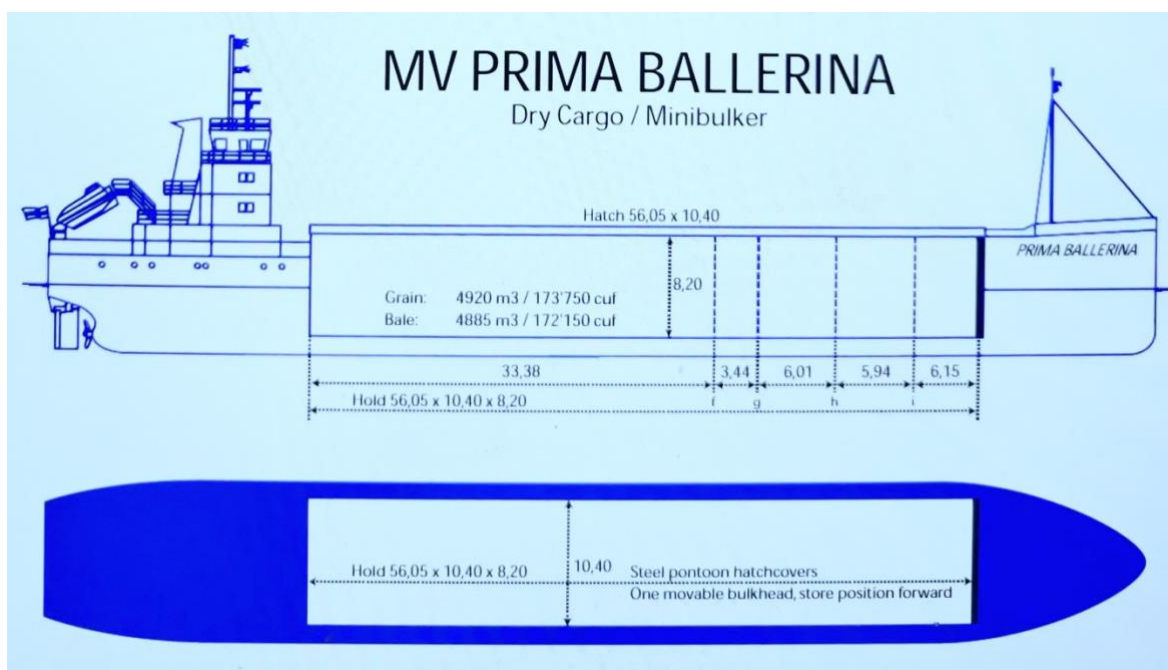
Figure 1 Layout of M/V Prima Ballerina (Prima Shipping Group, 2016)

M/V Prima Ballerina was built 1986 in Sietas Shipyard, Germany. Length over all 87.99m, and width 12,80m with gross tonnage of 2673 designed to carry general cargo or bulk cargo. She has folding type steel ponton hatch cover opening one to aft and one to forward. Hatch covers are divided in four sections to be able to open or close half of the hatch cover in the aft or forward. Cargo hold can be divided in two parts, for separation of cargo, with the movable bulkhead that is stored in forward of the cargo hold. When the bulkhead is in stored position in forward, only ladders and access to the cargo hold is in the aft. (Prima Shipping Group, 2016)

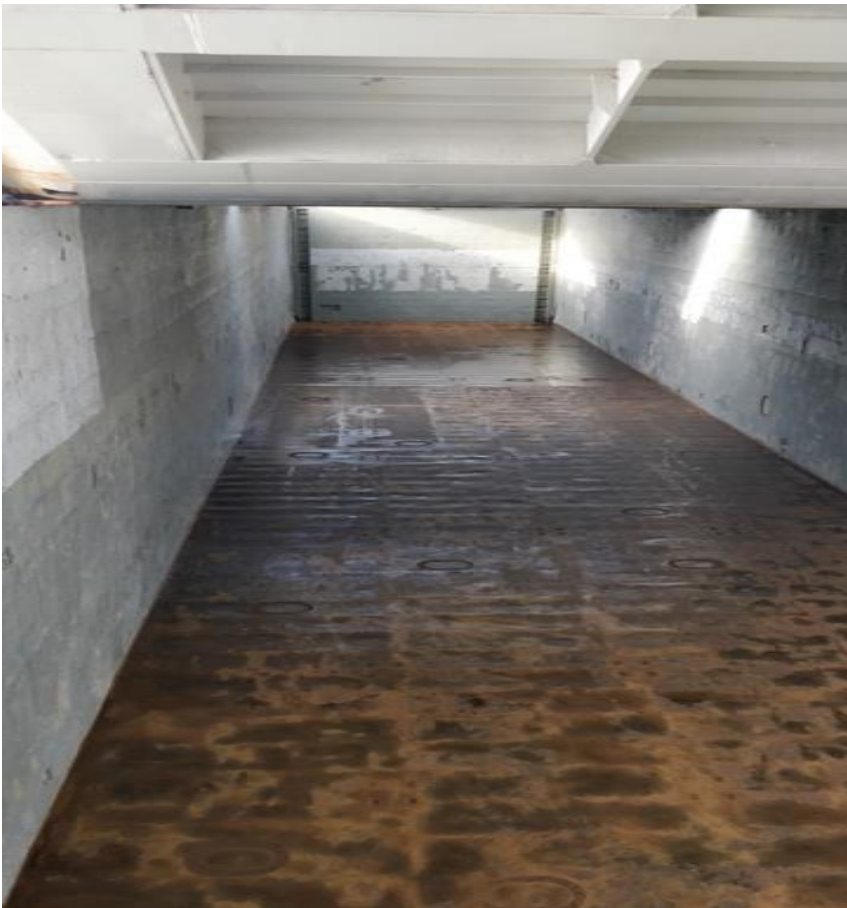
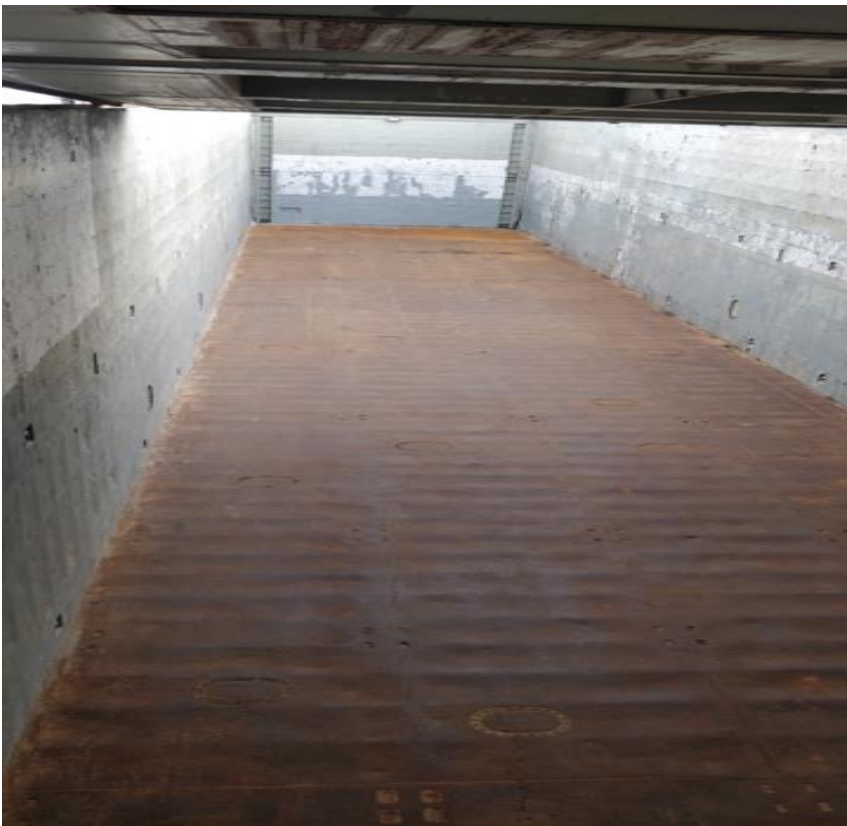
Figure 2 Wet vs dry Cargo hold (Matti Heinonen 2020)

Cargo hold must be clean and dry is a phrase you always hear from inspector already in first emails they are sending before inspection. This is also what inspector check first, already on deck looking done to cargo hold, is it clean and specially is it dry. Inspector will also check the sides inside of the cargo hold that there is not moisture. Cargo hold inspector checks that there is no dirt, that can affect to cargo example sweeping the sides and tank top with the white cotton glove to see if there is some dirt. Old cargo residues may exist depending on cleanliness grade required but loose paint, paint chips, loose rust and any kind of other dirt, old cargo lashing equipment or garbage are prohibited and must be removed. Definition of loose paint and loose rust is, that if it can be removed, when there is applied strike with fist or light pressure with knife or scraper edge of the scale. In the cargo hold there can be oxidation rust usually on bare surfaces with no paint but if it is light and can't be removed by using knife or scraper with light pressure applied, mostly can be seen on tank top, it will be accepted. (Seven Surveyor, 2013)

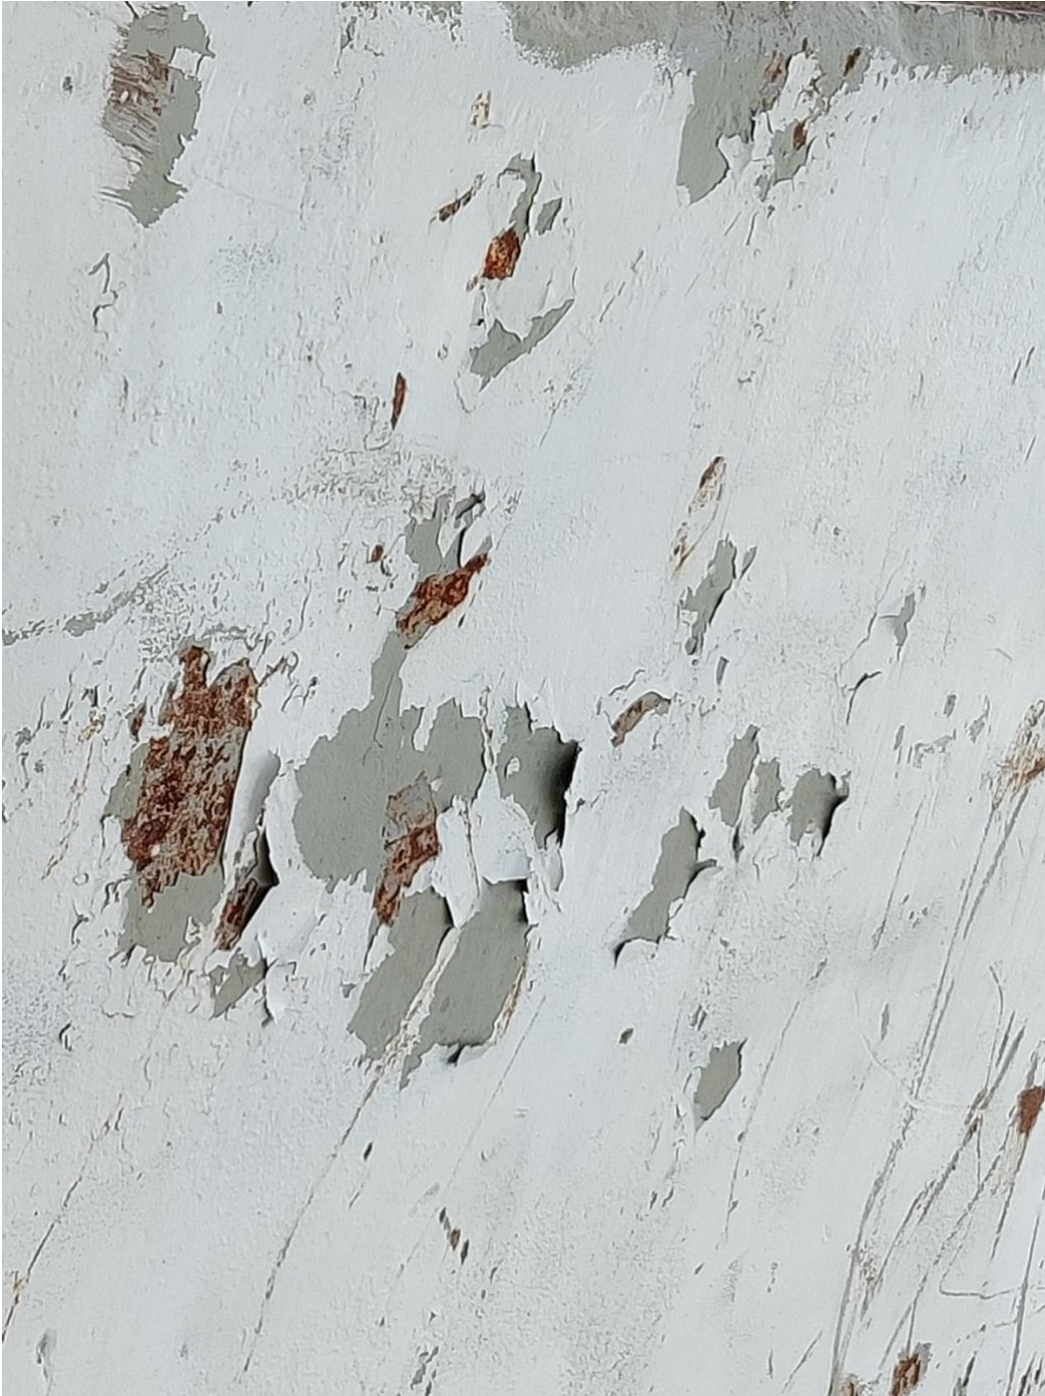
Figure 3 Loose paint side of the cargo hold (Matti Heinonen 2021)

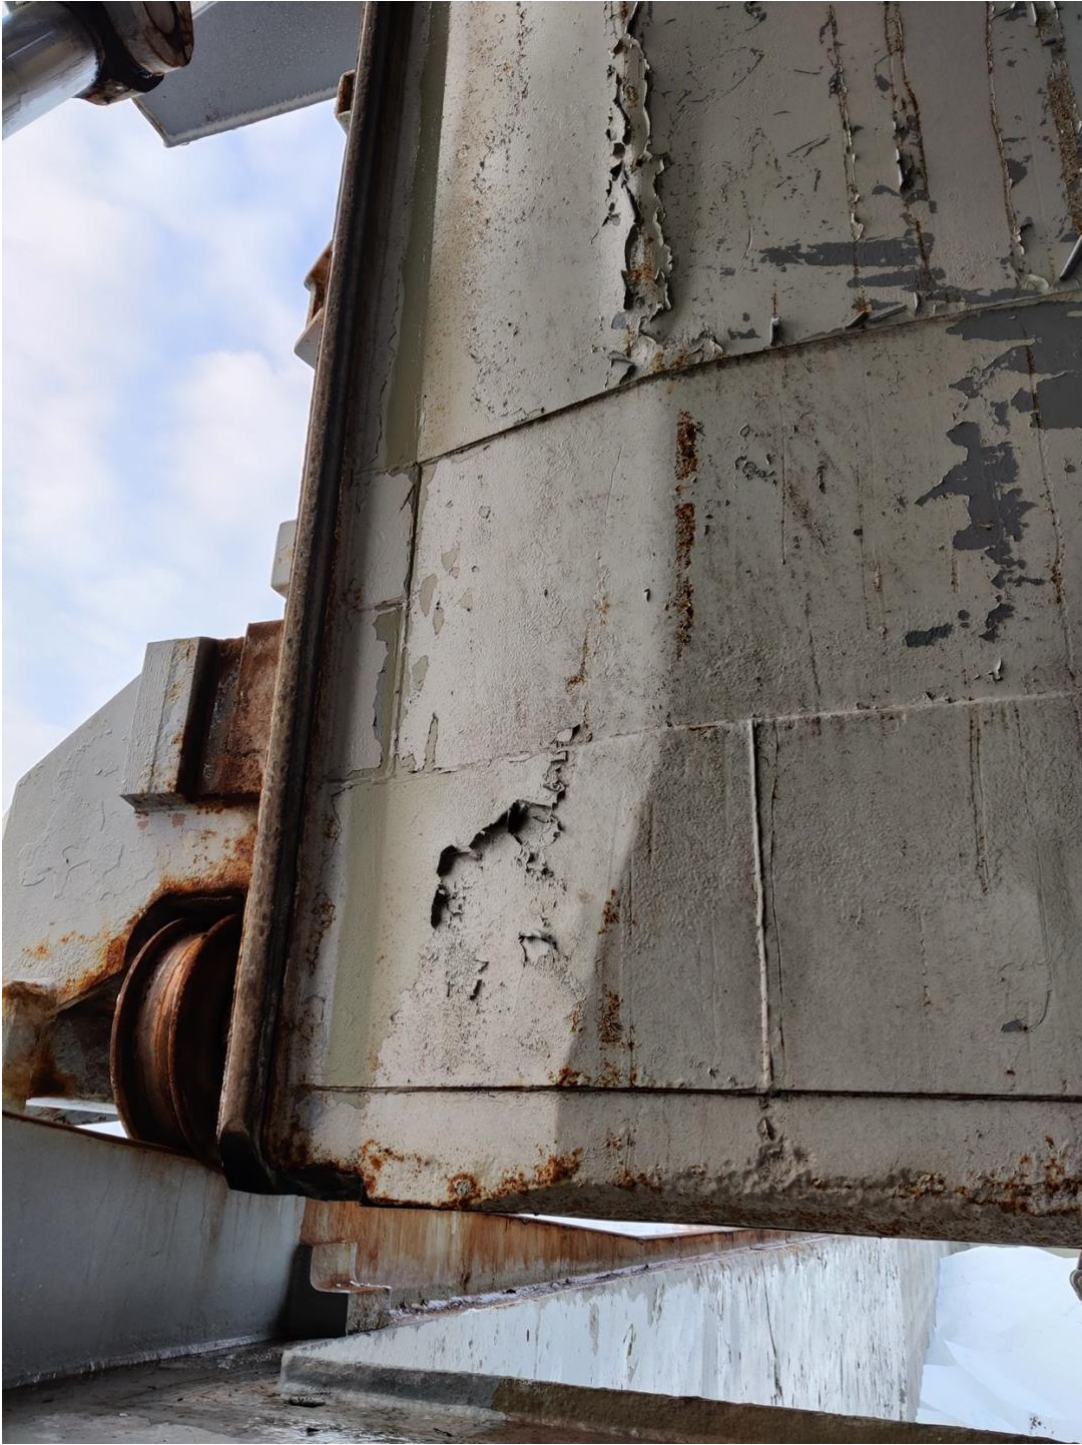
Figure 4 Loose paint on hatch cover (Matti Heinonen 2021)

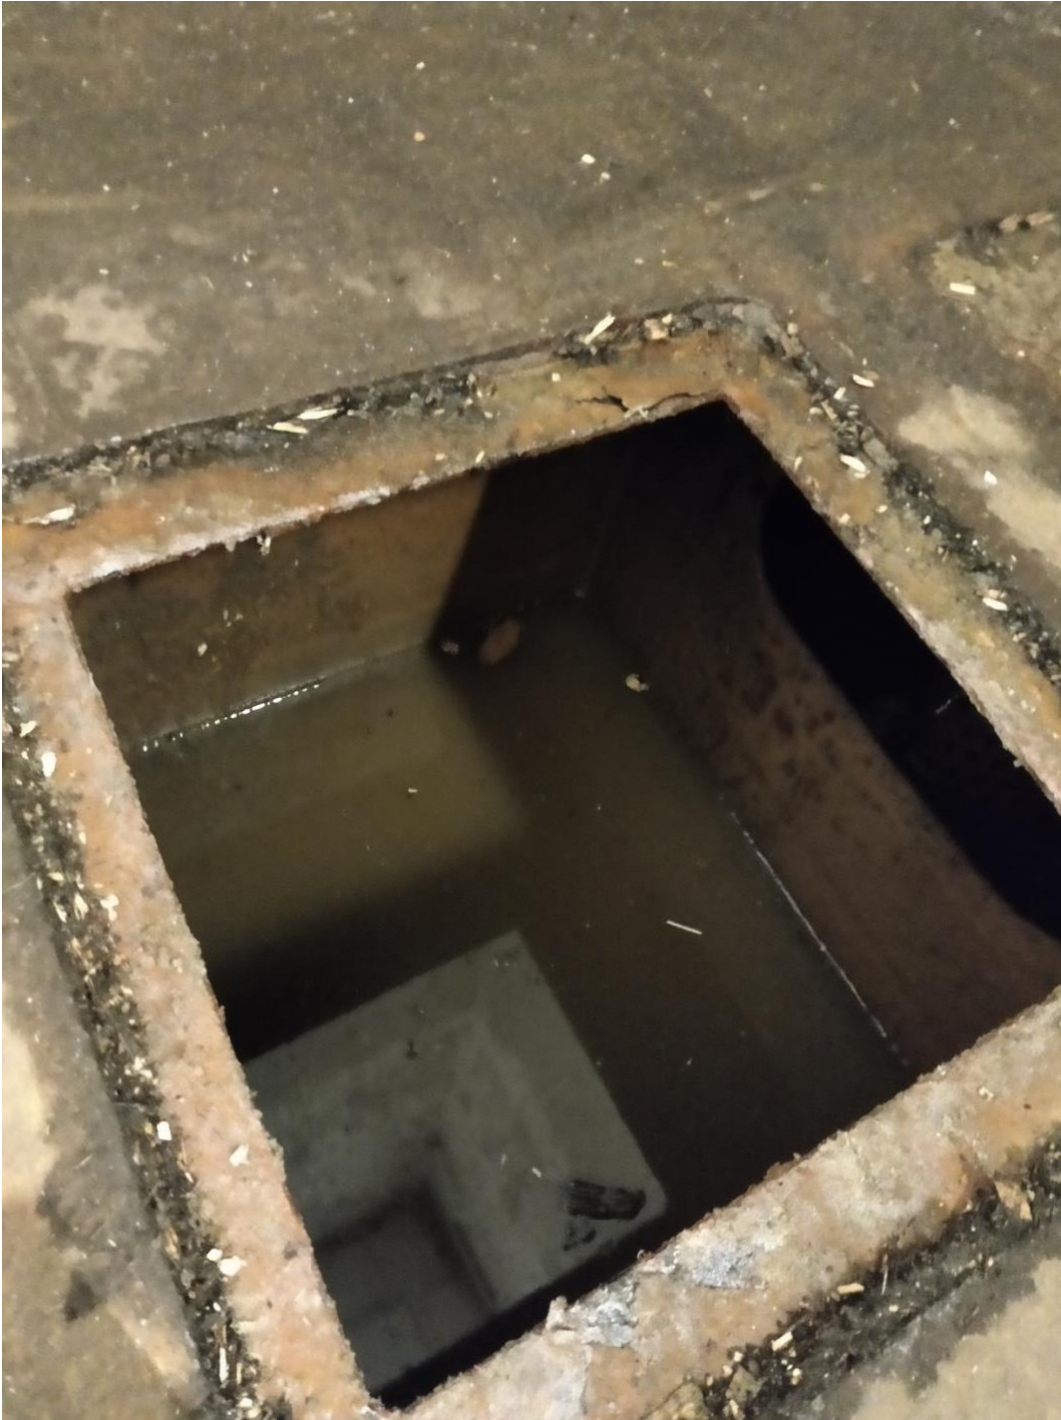
Figure 5 Bilge well full of water (Matti Heinonen 2021)

Bilges are important to check that those are operational function. Bilge wells should be clean and dry. Strum boxes and strainers has to be cleaned well. With certain cargoes bilges will be covered with burlap and secured with duct tape to ensure cargo stay outside the bilges but water can still enter the bilges in case cargo releases water, cargo containing water or in worst case leakage of ship hull, so the water can be pumped out. Bilge covers should not be placed beforehand because inspector would like to check inside the bilge to check the bilge condition. (Spencer, et al., 2011)

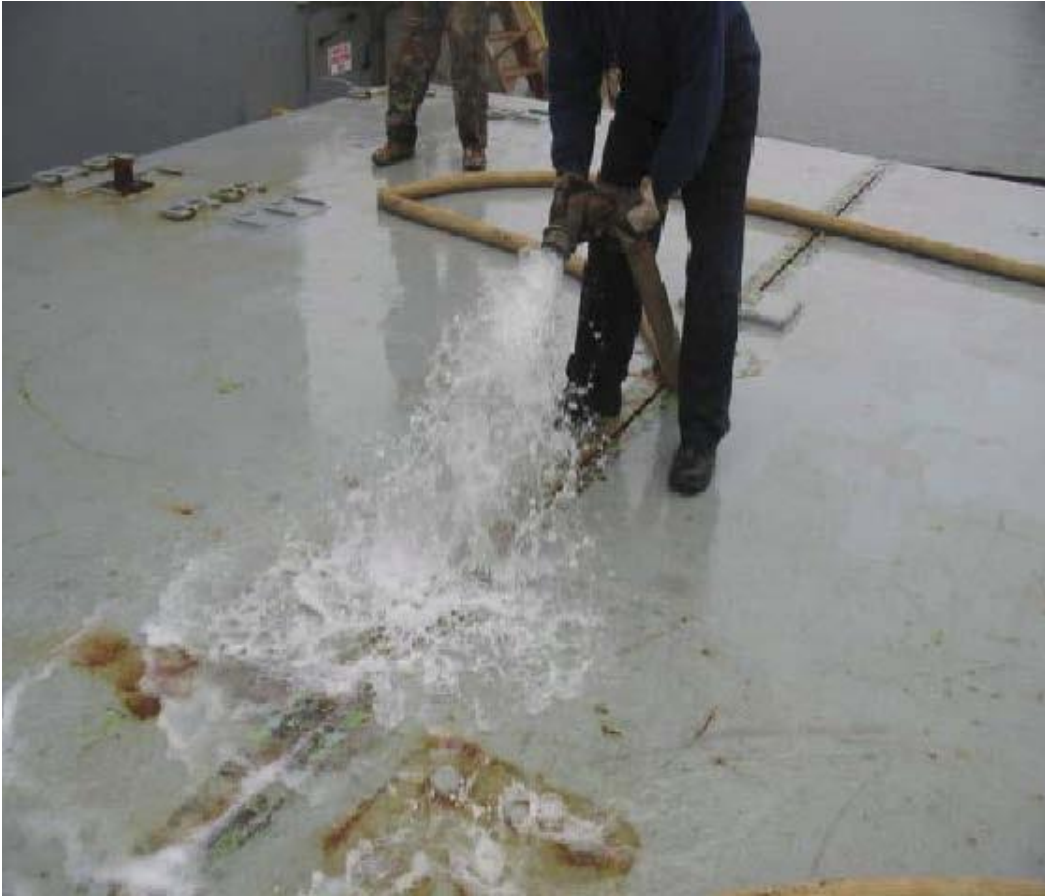
Figure 8 Hose testing (Bulk Carrier Guide, 2010)

Hose test is very common method to test the hatch cover weathertightness. Hatch covers will be closed and secured well. Ship crew prepare ex. firehose and nozzle. Surveyor and chief officer go inside the cargo hold while another surveyor and ship crew stays outside. Hatch covers will be circulated around applying water with high pressure to all hatch joints. Surveyor in the cargo hold go around same track and same time that water will be applied outside. Surveyor is looking if there is coming any leakage inside the cargo hold through hatch cover joint. Hose test result is based on visually checking is there any water penetrating through hatch cover joint and sealing. (Lloyds's register / The Standard, 2002)

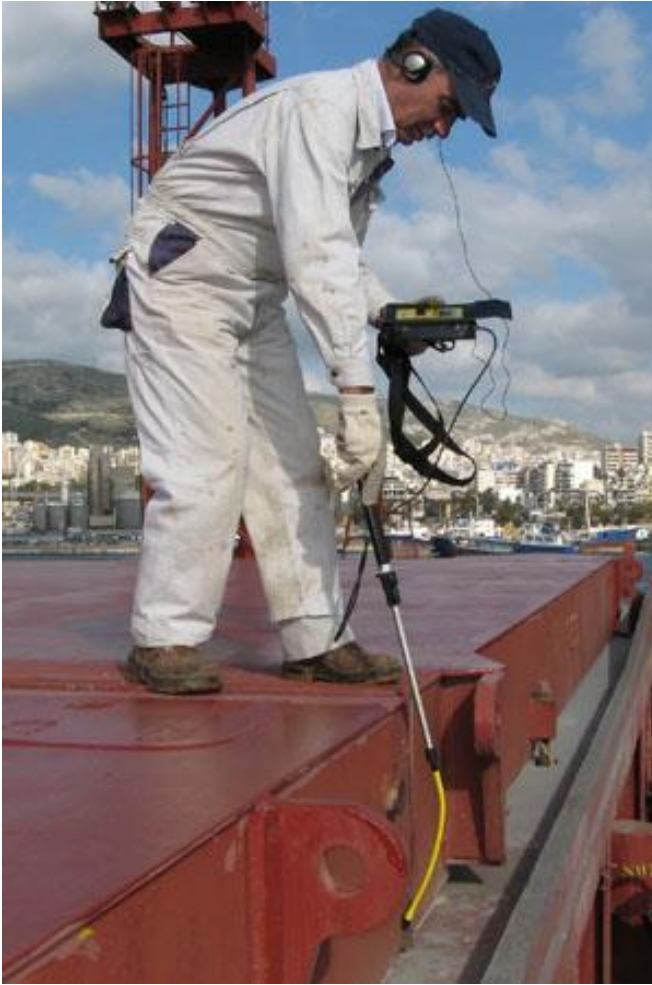
Figure 9 Ultrasonic test (Overseas Maritime, 2018)

Ultrasonic test is the most strict and accurate method to check hatch cover weathertightness. This test has to be performed by competent surveyor who is holding ultrasonic operator certificate. In ultrasonic is based equipment detecting sound. Sound emitter is placed inside the cargo hold and surveyor go around the hatch cover joints with sound detector. Results will be written down in report that is also handed to vessel. (Skuld/ Anatoliy Frank, 2021)

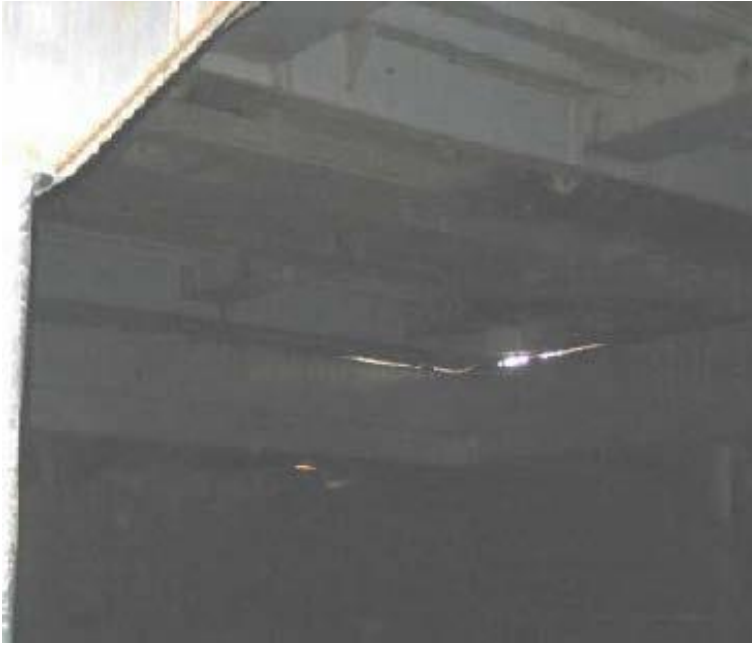
Figure 10 Light infiltration test (Bulk Carrier Guide, 2010)

Light infiltration test shows if there is a visually detectable opening between the hatch cover and the hatch coaming. Hatch covers will be closed and then entered to the cargo hold. If there is light coming between the hatch cover and the coaming, it is clear that there is an opening and a possible point of leakage. (Bulk Carrier Guide, 2010)

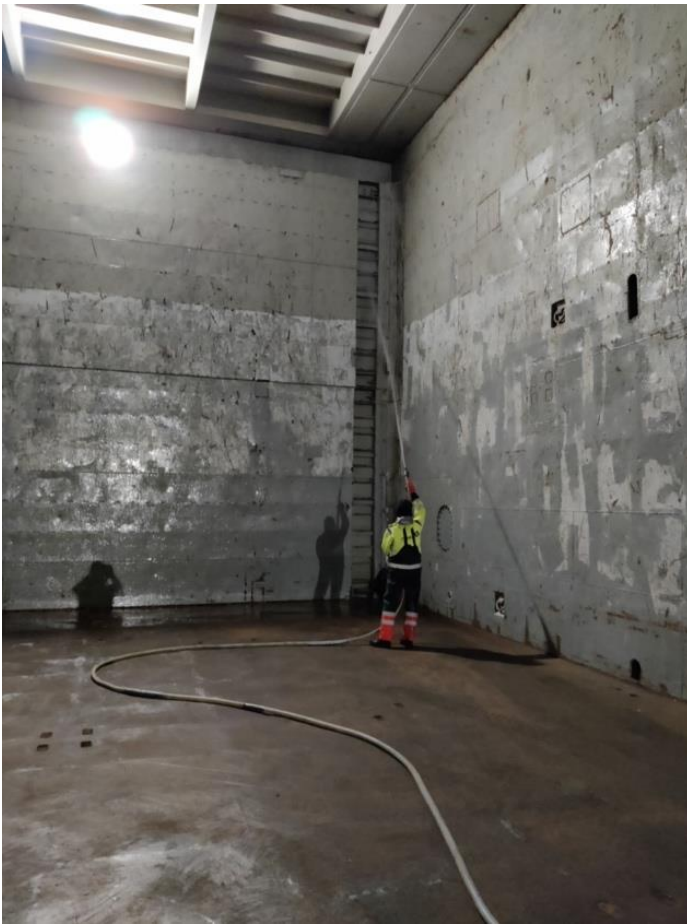
Figure 11 Bosun cleaning cargo hold with water hose (Matti Heinonen 2021)

Depending on cleanliness grade required cargo hold must be washed or swept to remove all dirt and cargo residues. After cleaning, check that there isn't any loose paint or rust scale. All loose paint and rust scale has to be removed. New paint should be applied always when have time and side plaiting requires it. Paint should not be applied to tanktop due to it gets hits from crane grab and bulldozer which can sever the paint that get mixed with cargo. Bilges has to be cleaned and dried and ensure those proper working condition. (c.f. Paragraph 3.1 & 3.3)

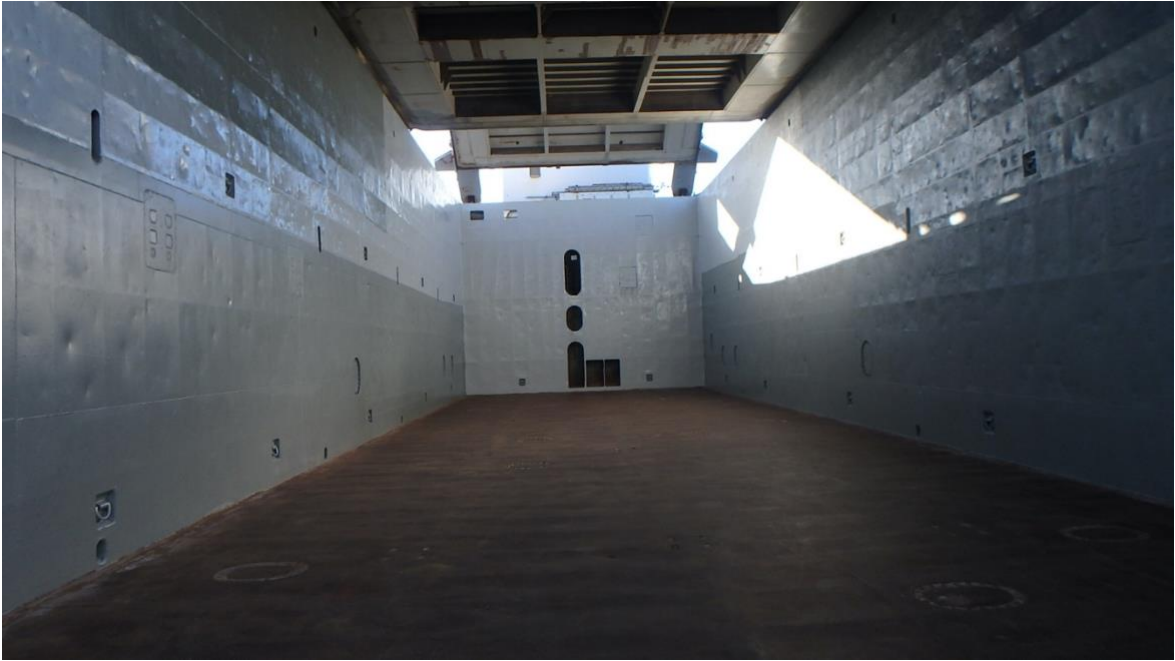
Figure 13 Optimal situation, freshly painted cargo hold during few days lay time at Ostend (Matti Heinonen 2020)

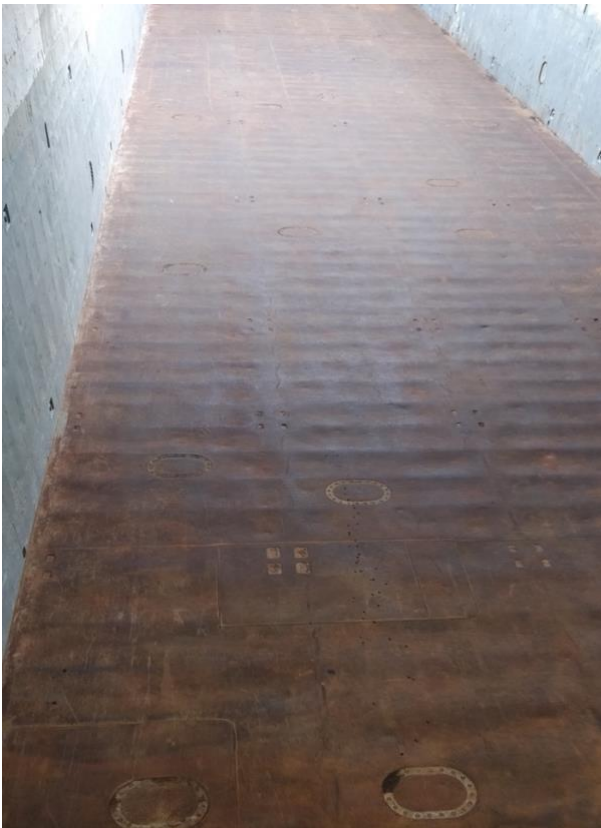
Figure 14 Clean and dry tanktop (Matti Heinonen 2021)

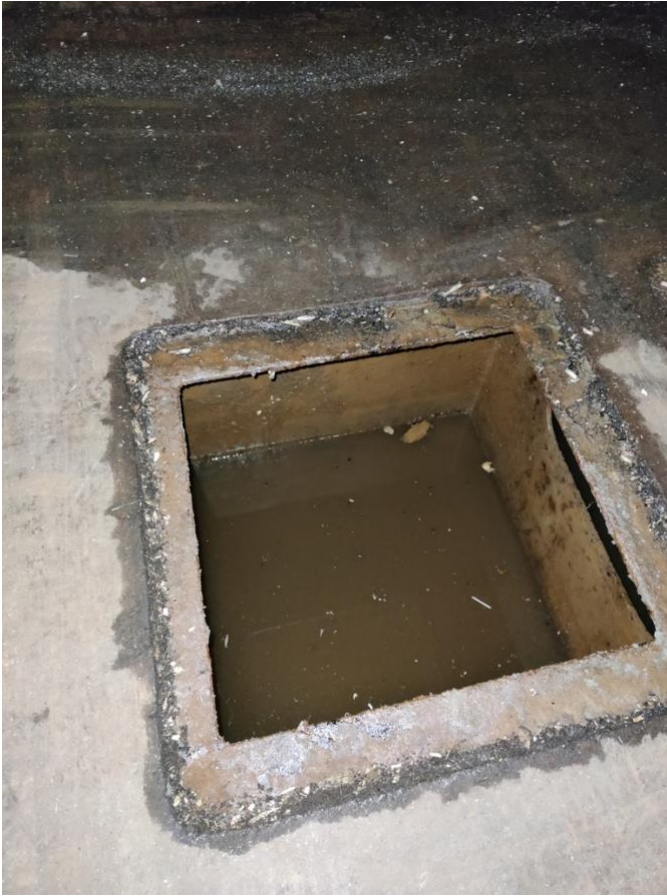
Figure 15 Bilge full of water after washing that needs to be cleaned (Matti Heinonen 2021)

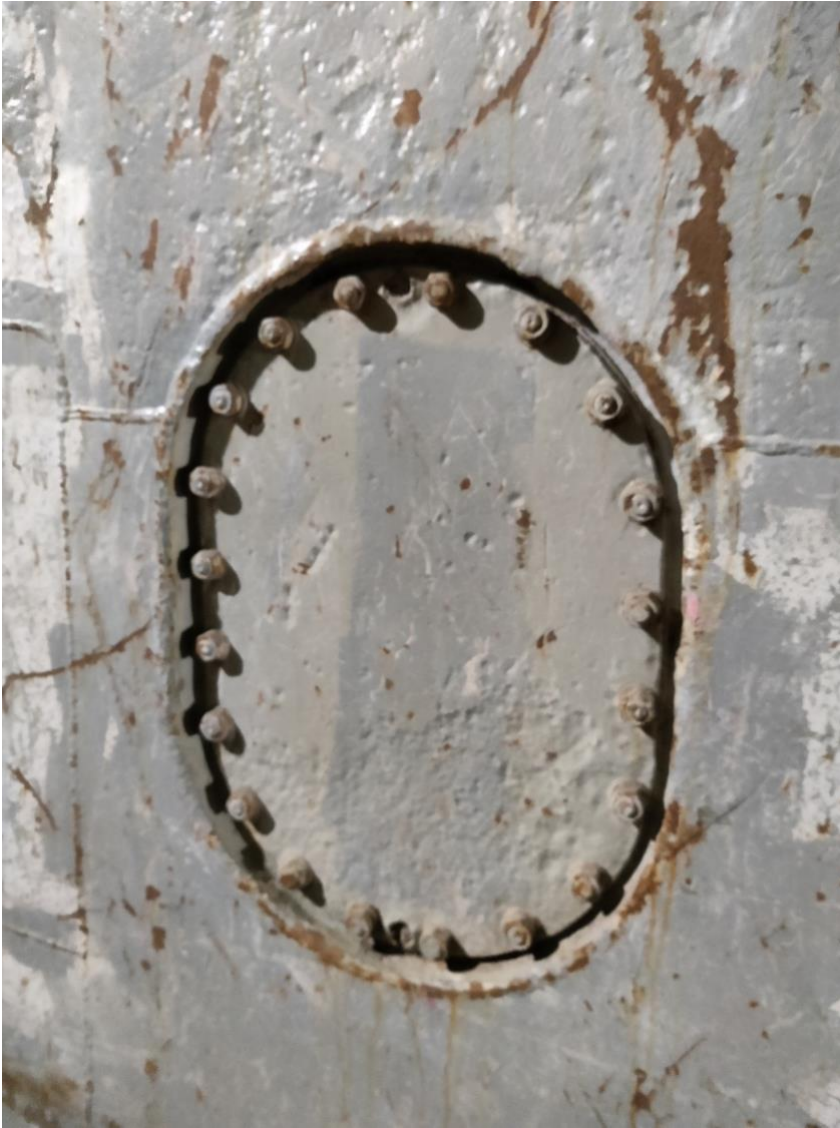
Figure 16 Side plating manhole (Matti Heinonen 2021)

All the uneven spots at the cargo hold gathers dirt and cargo residues. Manholes, lashing points and tanktop container sockets have to be checked and cleaned from dirt, cargo residues. Manholes and container sockets at the tanktop is filled with concrete to make tanktop more even not to collect dirt, cargo residues and prevent bulldozer bucket to hit and damage tanktop. Concrete condition has to be checked that there isn't any loose concrete. Loose concrete pieces must be removed and replaced. (c.f. Paragraph 3.1 & 3.3)

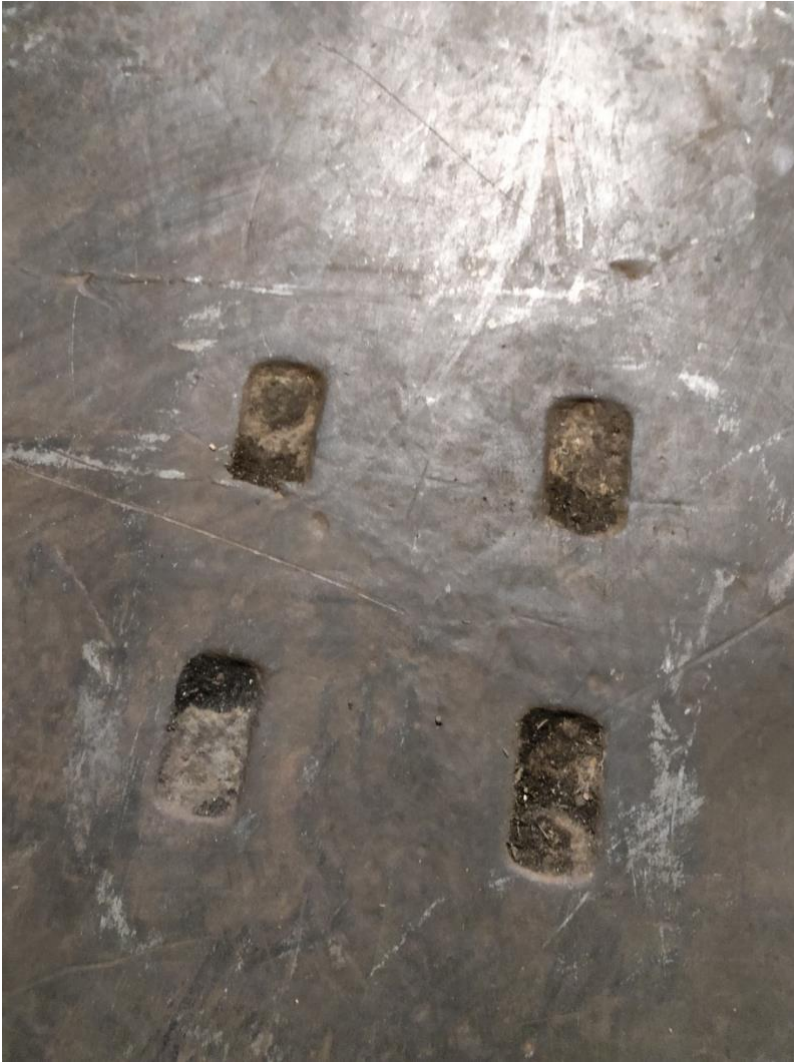
Figure 17 Tanktop container socket with damaged concrete and dirt (Matti Heinonen 2021)

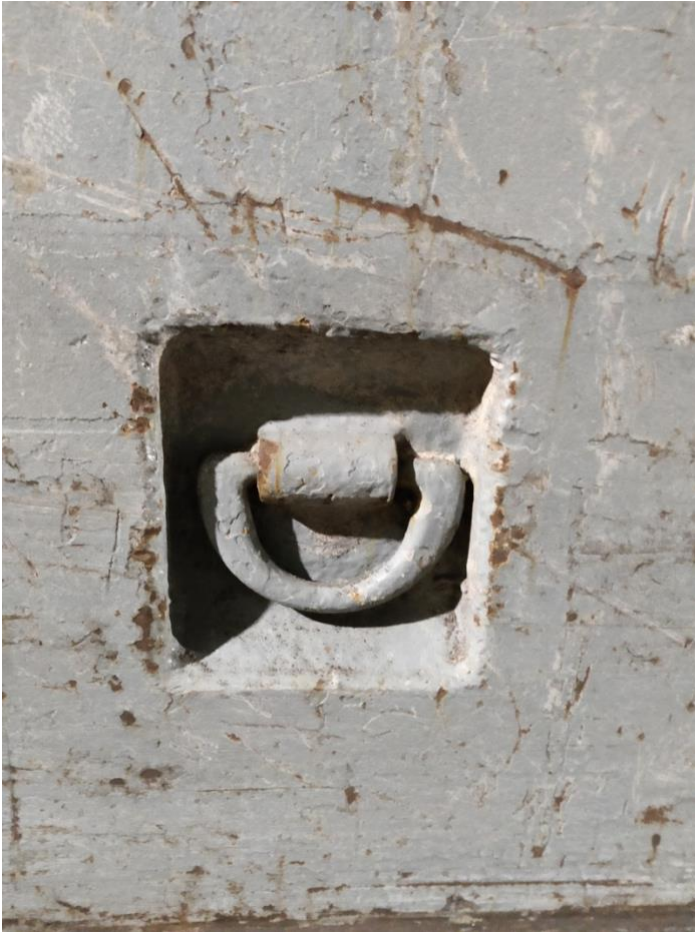
Figure 18 Side plaiting lashing point. Showing little cargo residue between plaiting and lashing ring (Matti Heinonen 2021)

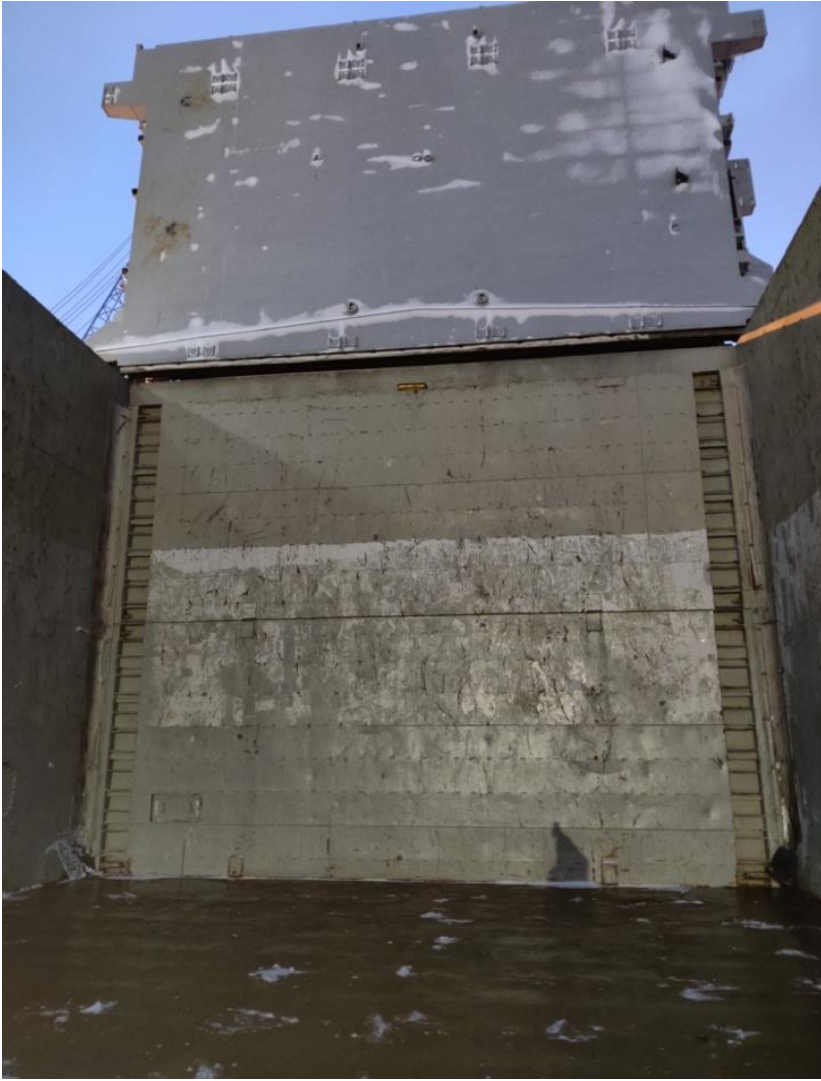
Figure 19 Bulkhead in stored position at forward. (Matti Heinonen 2021)

M/V Prima Ballerina has the movable bulkhead of which purpose is give means to separate different cargos. Its stored position is at forward of the cargo hold. All the loose paint and rust scale checks apply also to bulkhead but it is also necessary and important to check bulkhead specific characteristics. There is ladders both side of the bulkhead port and starboard that collects dirt and cargo residues. Sides of the bulkhead is applied rubber rug from top to bottom to seal sides of the bulkhead. It is necessary to check behind the rubber rug that there isn't any cargo residues and dirt. One important thing is check under the bulkhead and top of the bulkhead that is has been cleaned well. In the side plaiting there is sockets to attach bulkhead when moved from stored position. Due to shape and depth of these sockets those are major spots to collect dirt and cargo residues. (c.f. Paragraph 3.1& 3.3)

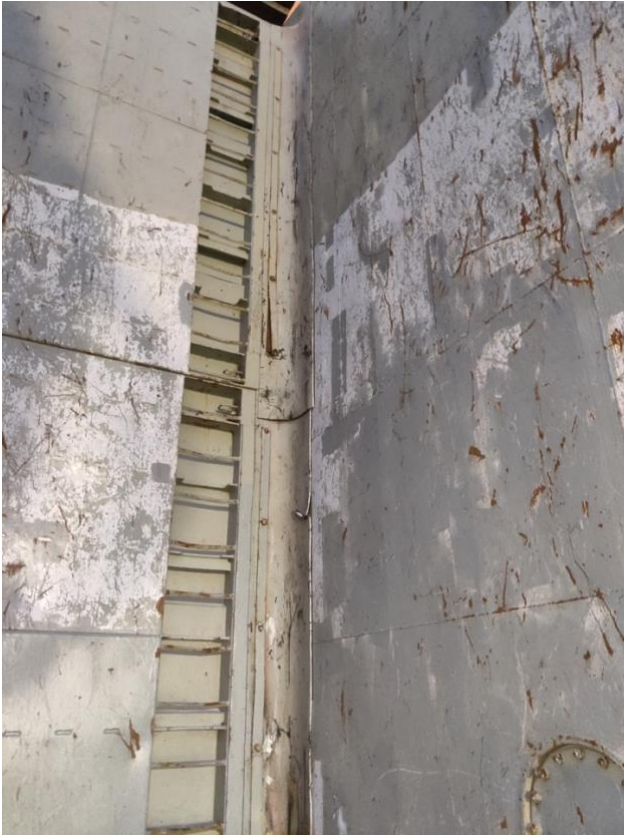
Figure 20 Bulkhead ladders (Matti Heinonen 2021)

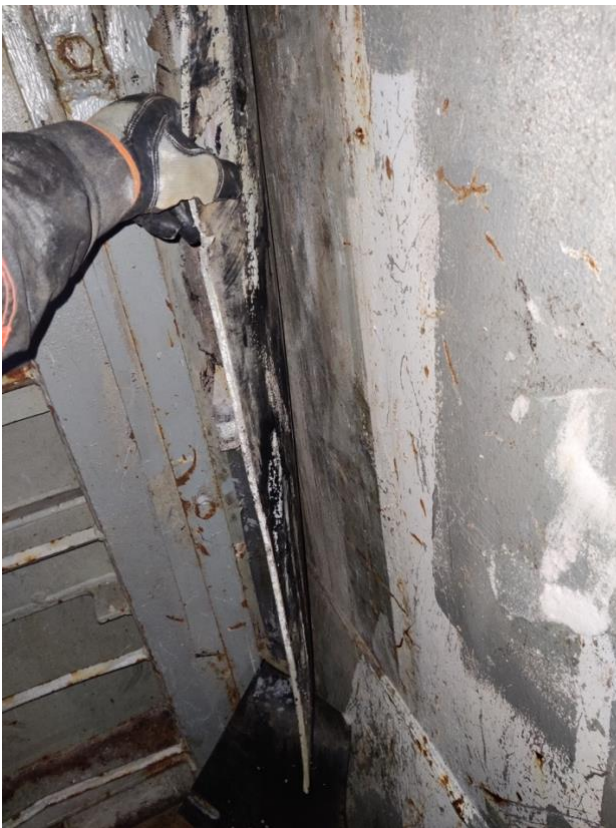
Figure 21 Check behind the rubber rug. (Matti Heinonen 2021)

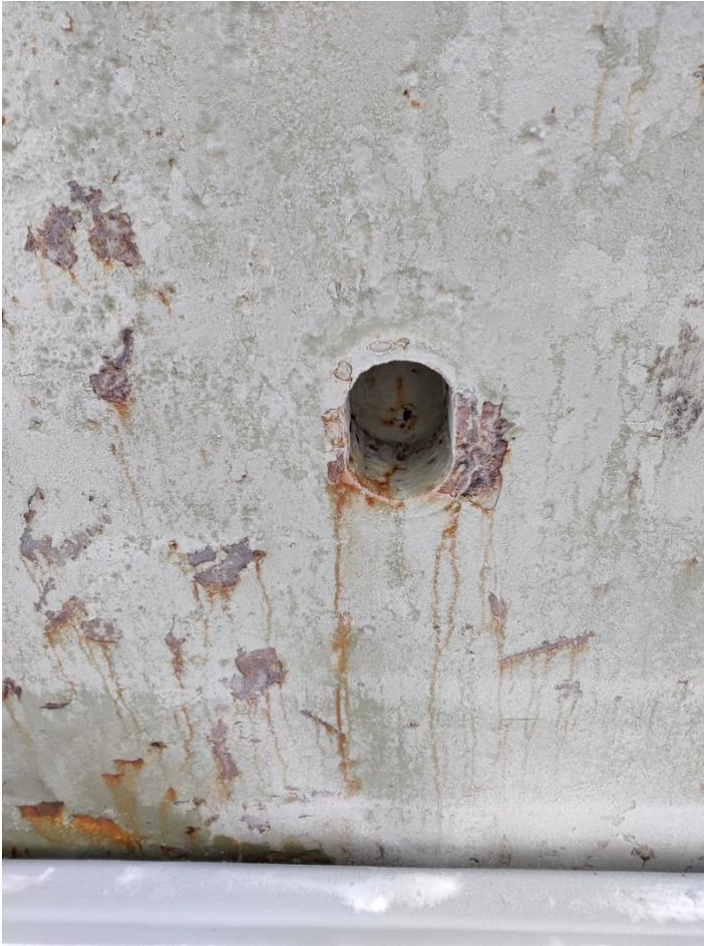
Figure 22 Bulkhead attachment socket. No cargo residues but some loose rust and paint. (Matti Heinonen 2021)

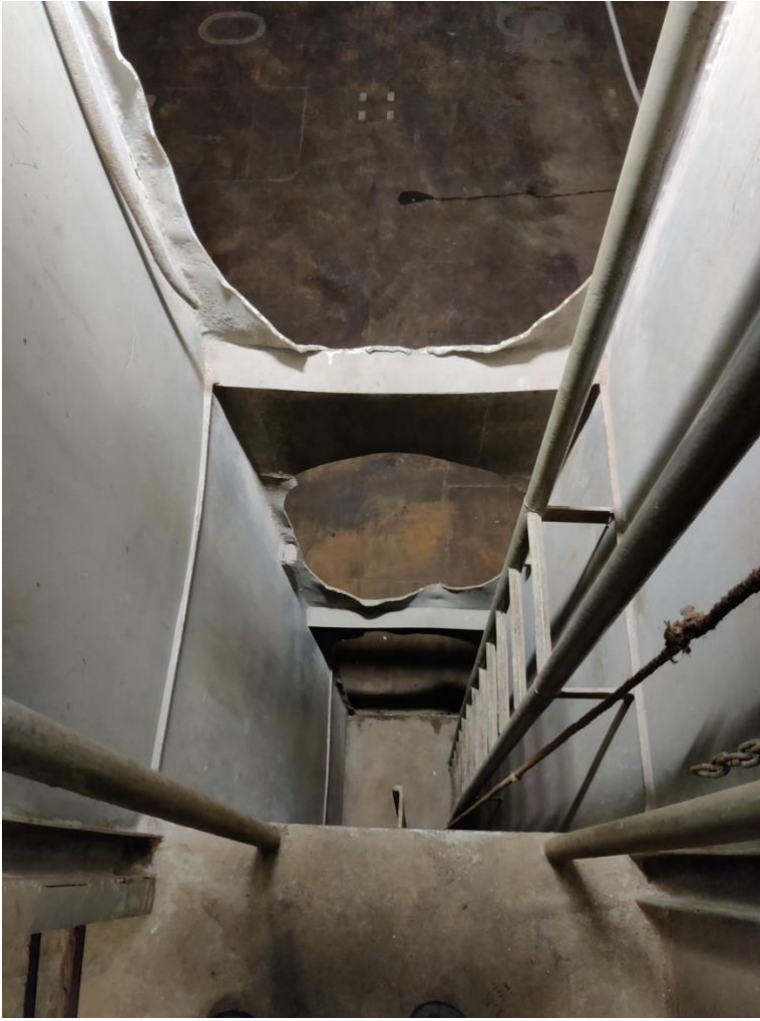
Figure 23 Aft cargo hold ladders and housing. (Matti Heinonen 2021)

Cargo hold ladders are placed in the aft of the cargo hold. Ladders are covered with side plaiting. When loading the cargo enters in the housing of ladders. Ladders and housing has to be cleaned well also because it is the first thing what surveyor sees when entering cargo hold to make good first impression. Another cargo hold ladders are placed in the forward but can be used only when bulkhead isn't in the stored position. Entrance is located between forward mooring station and cargo hold. Due to entrance position, there is always water splashing to it and it might be source for leakage to the cargo hold. (c.f. Paragraph 3.3 & 3.5)

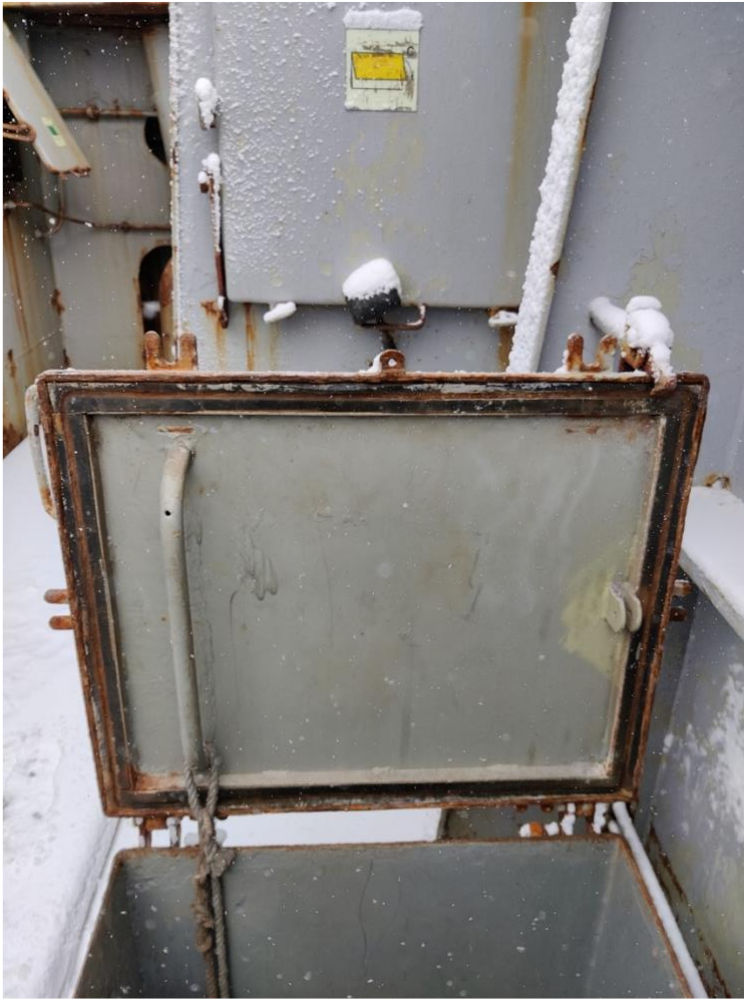
Figure 24 Forward cargo hold entrance. Sealing gasket to be checked. (Matti Heinonen 2021)

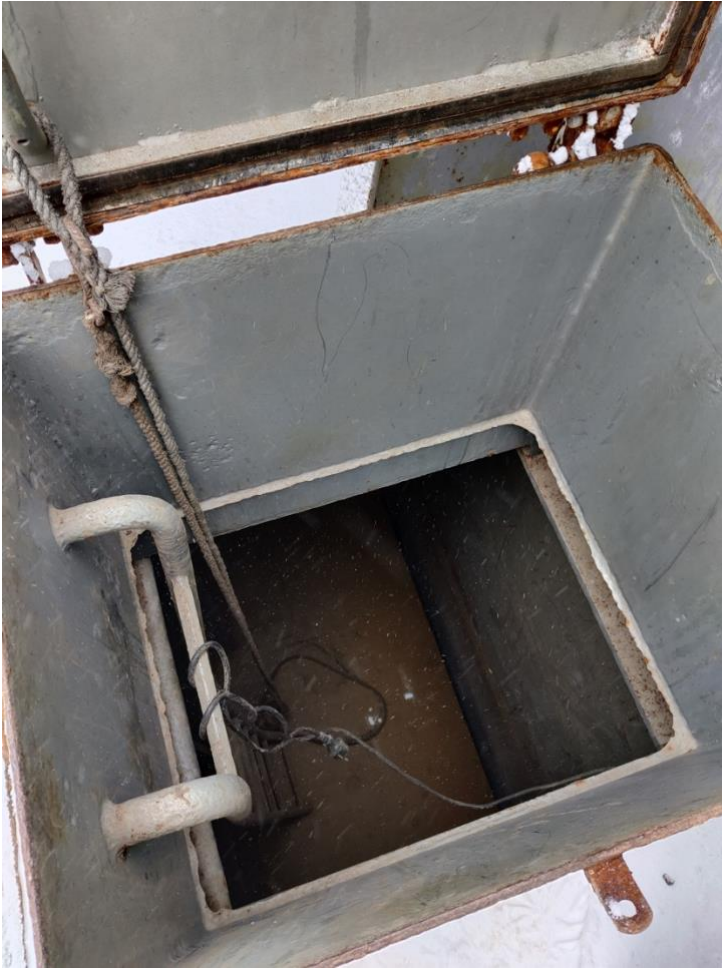
Figure 25 Forward cargo hold entrance. Good to check runoff marks from the sides to detect possible leakage. (Matti Heinonen 2021)

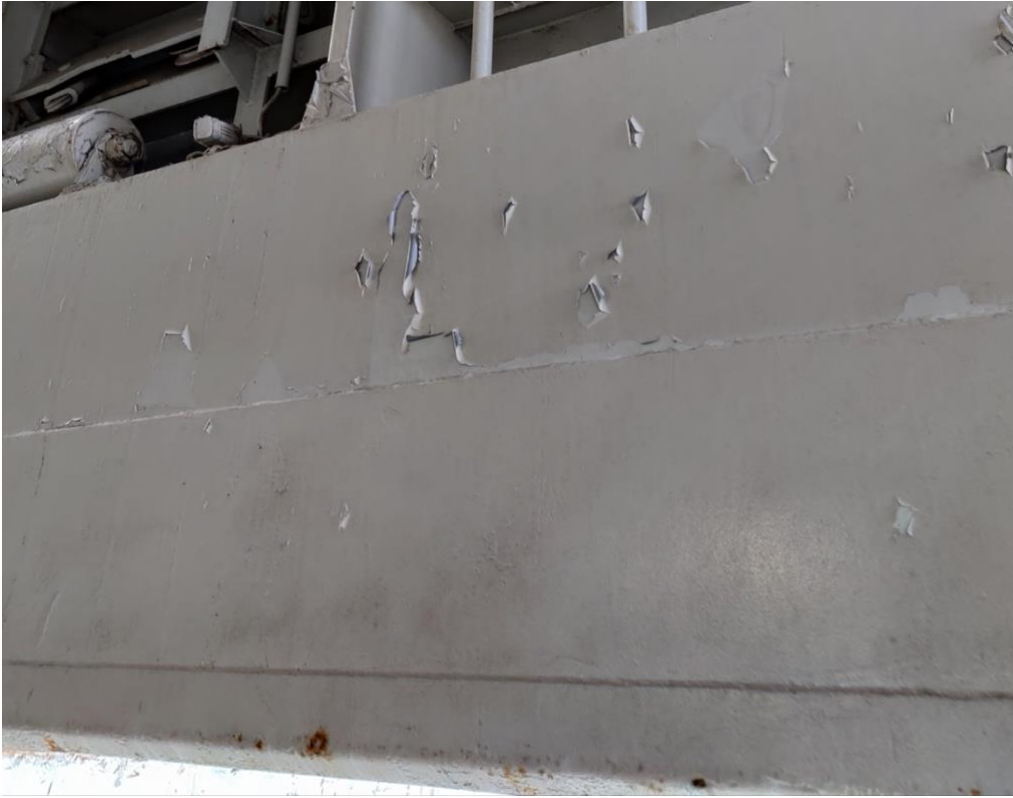
Figure 26 Loose paint on hatch cover. (Matti Heinonen 2021)

Check the hatch cover paint and rust condition. Hatch cover inside part must be carefully inspected that there is not any loose paint or rust scale that can be loosen and drop on top and mix with cargo. Joints between hatch cover has to be cleaned well that there is not any dirt that block the channel where water should be able to freely flow on deck. (c.f. Paragraph 3.5)

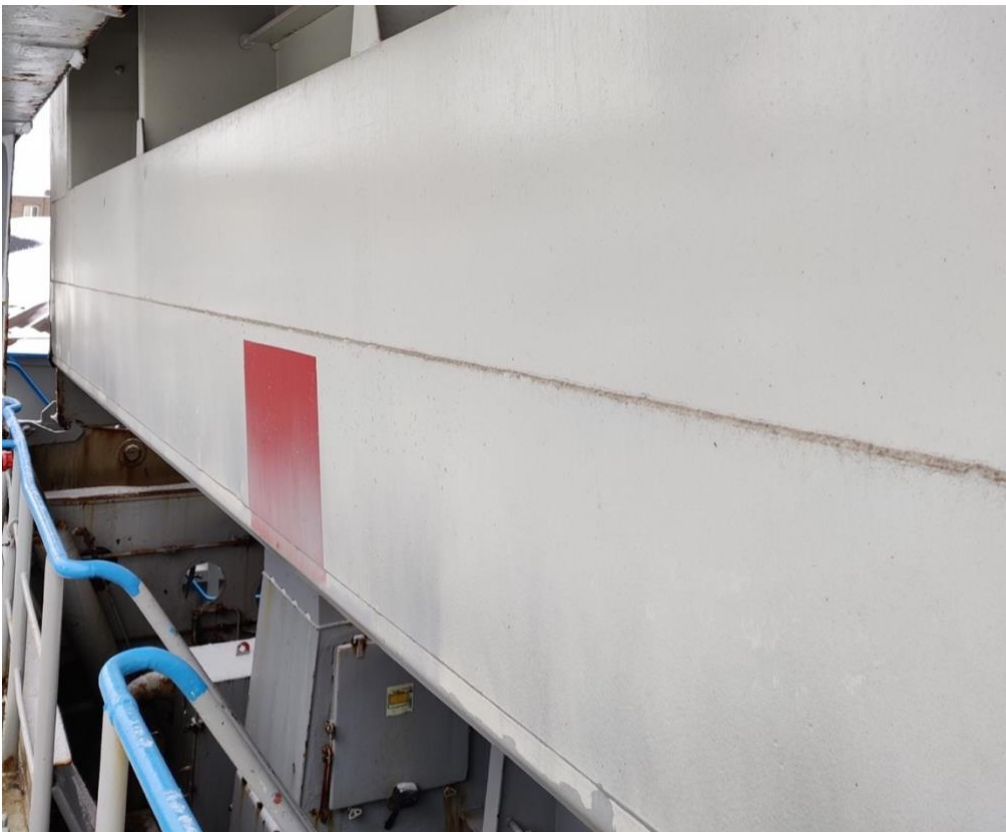
Figure 27 Intact paint on hatch cover. (Matti Heinonen 2021)
