Critical points to recognize when preparing M/V Prima Ballerina for cargo hold inspection

Degree Thesis for Bachelor Maritime Management

Title: Critical points to recognize when preparing M/V Prima Ballerina for cargo hold inspection

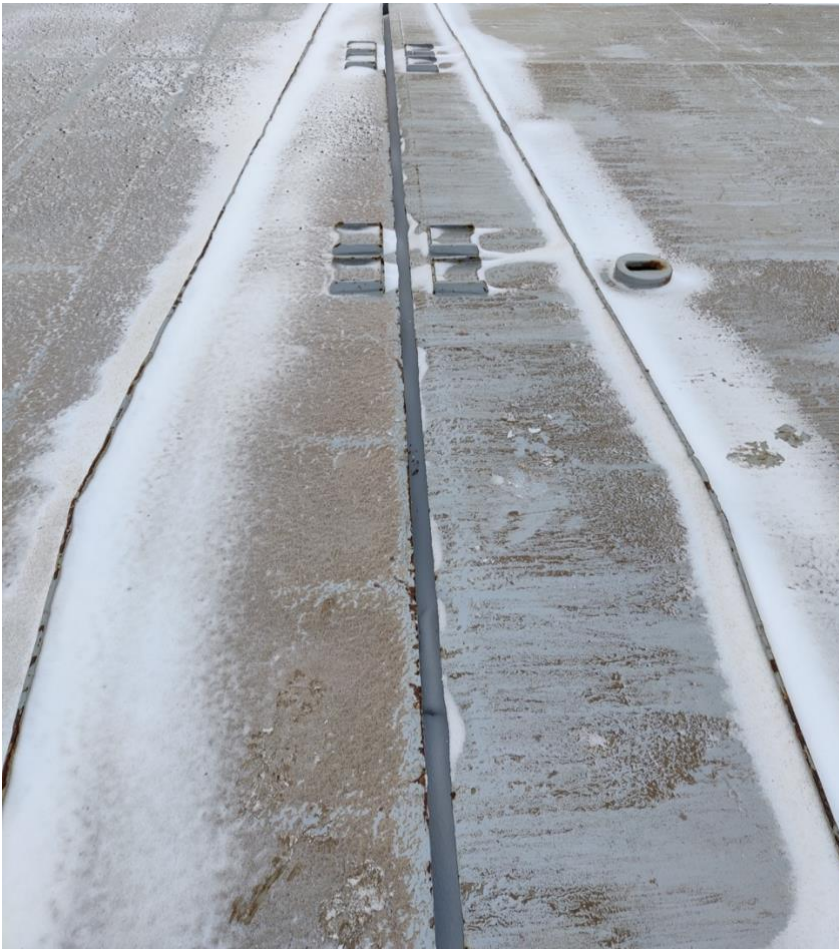
Figure 28 Snow in joint between aft and forward hatch cover. (Matti Heinonen 2021)

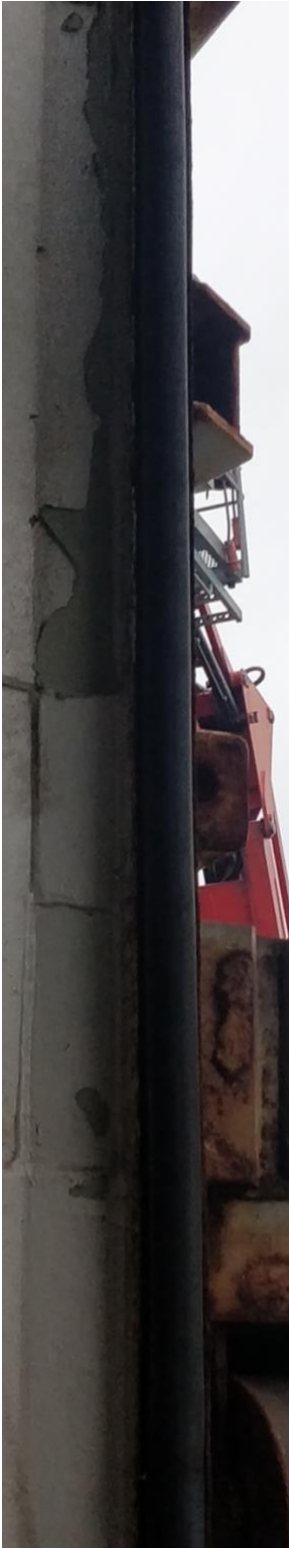
Figure 29 Hatch cover rubber packing/ rubber sealing gasket. (Matti Heinonen 2021)

Hatch cover rubber gasket is important to check due to defect in rubber gasket allows means for water to enter the cargo hold. Rubber gasket must be intact, dirt-free and all the gaskets that are hardened has to be replaced. Rubber gasket should be elastic otherwise it might let water penetrate through it and water can enter the cargo hold. (c.f. Paragraph 3.5)

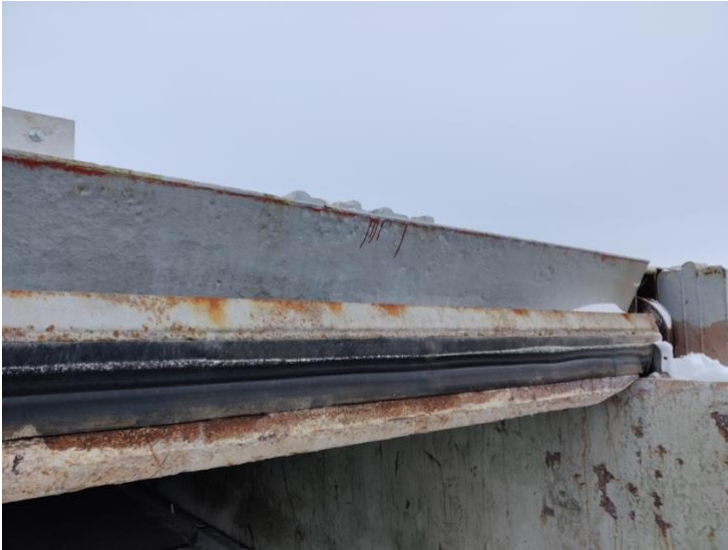
Figure 30 Hatch cover sealing gasket from mid-ship. Sealing between aft and forward hatch covers. (Matti Heinonen 2021)

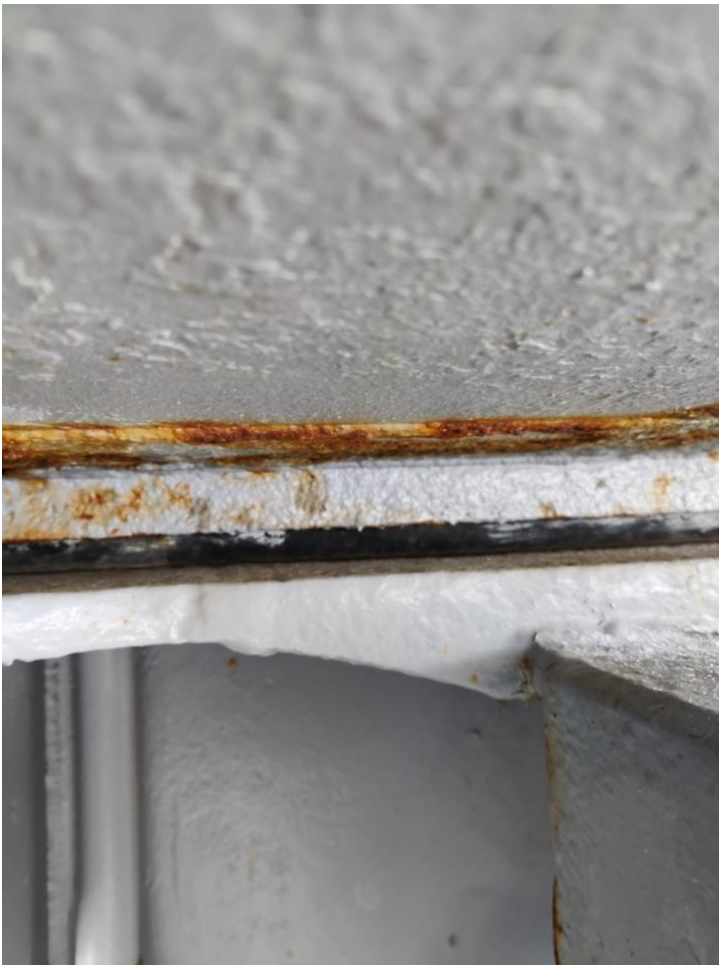
Figure 31 Closed hatch cover showing rubber packing against coaming. (Matti Heinonen 2021)

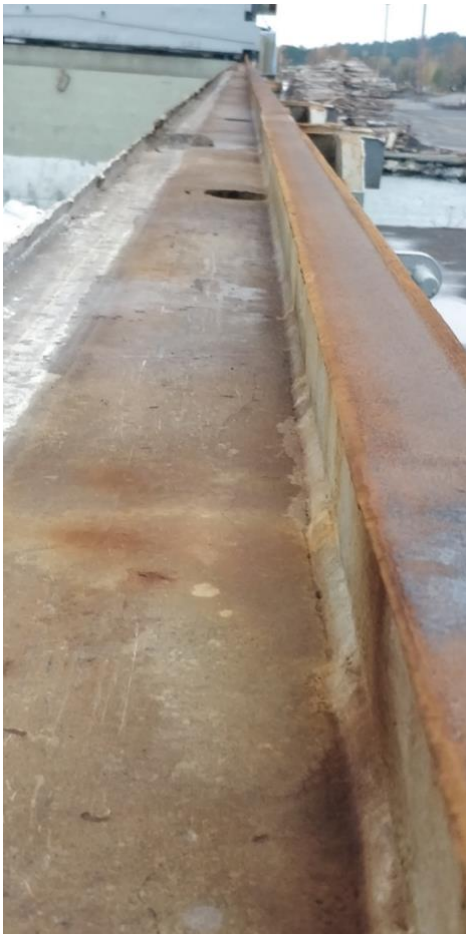
Figure 32 Hatch coaming and trackway. (Matti Heinonen 2021)

Hatch coaming and draining pipes including non-return valve must be cleaned and ensure those proper working condition. All loose rust and dirt must be removed that loose scale is not blocking the drainage channel. If the drainage channel is blocked it is more possible that water enters the cargo hold if there is leakage in rubber gasket. Trackway of hatch cover must be checked that there is not any loose scale that can block the drainage channel or rubber gasket. Draining valve must be inspected that the ball inside is moving and working so water can flow out but not inside. (c.f. Paragraph 3.5)

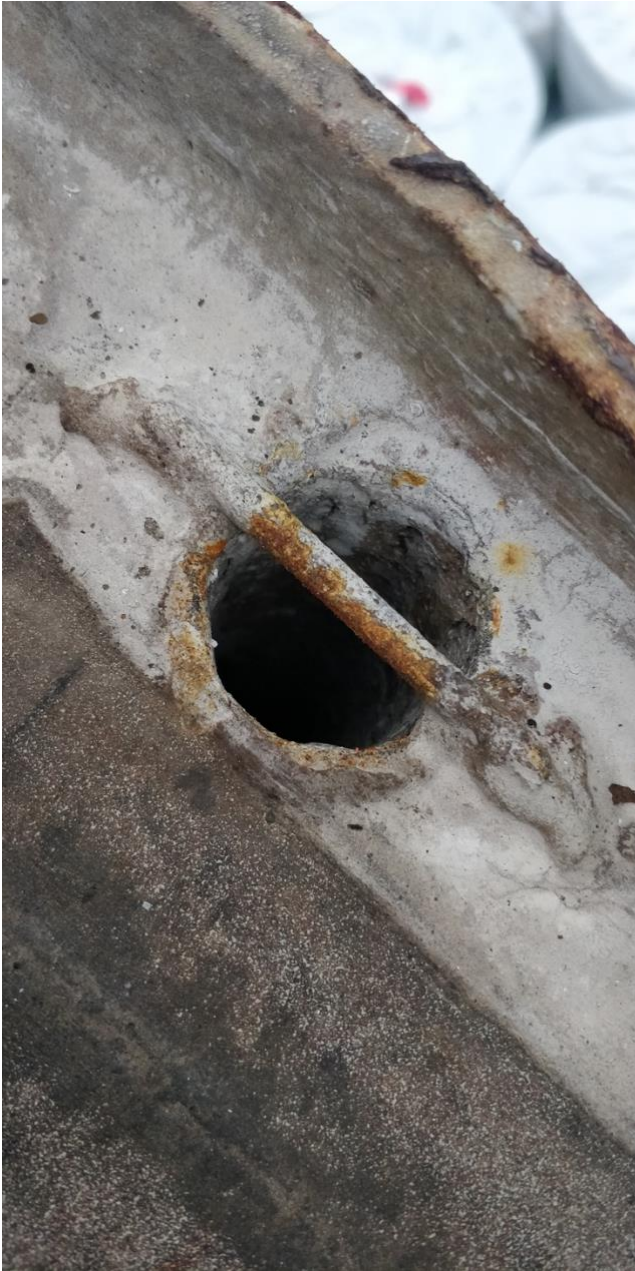
Figure 33 Draining pipe. (Matti Heinonen 2021)

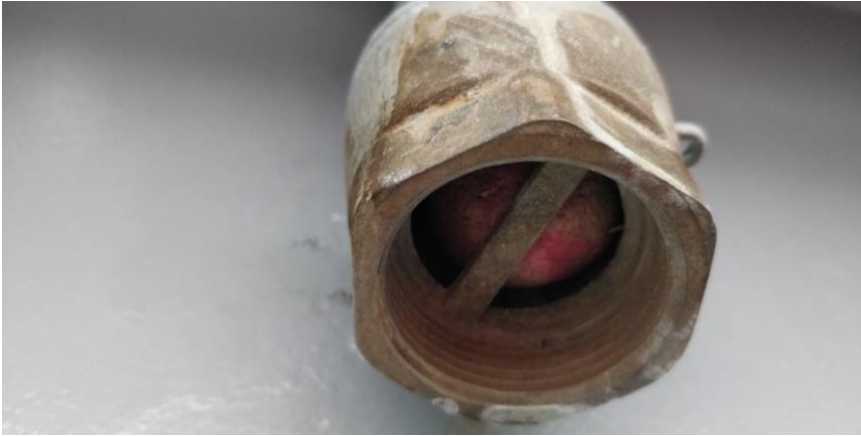
Figure 34 Draining valve. Ensure that ball inside is moving. (Matti Heinonen 2021)

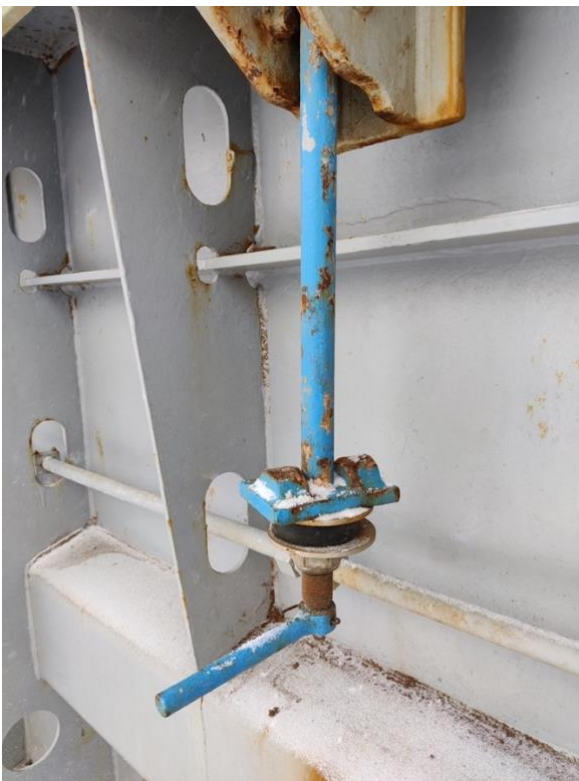
Figure 35 Quick acting cleat open position. (Matti Heinonen 2021)

Ensure proper working condition of quick acting cleats and cross joint cleats. Quick acting cleats rubber packing should be elastic to ensure that it can be tighten. Quick acting cleats tightness has to be checked before weathertightness test that those are tight enough providing more pressure to hatch cover. Cross-joint cleats should be checked that those are not bend or damaged anyway so that those working properly. (c.f. Paragraph 4)

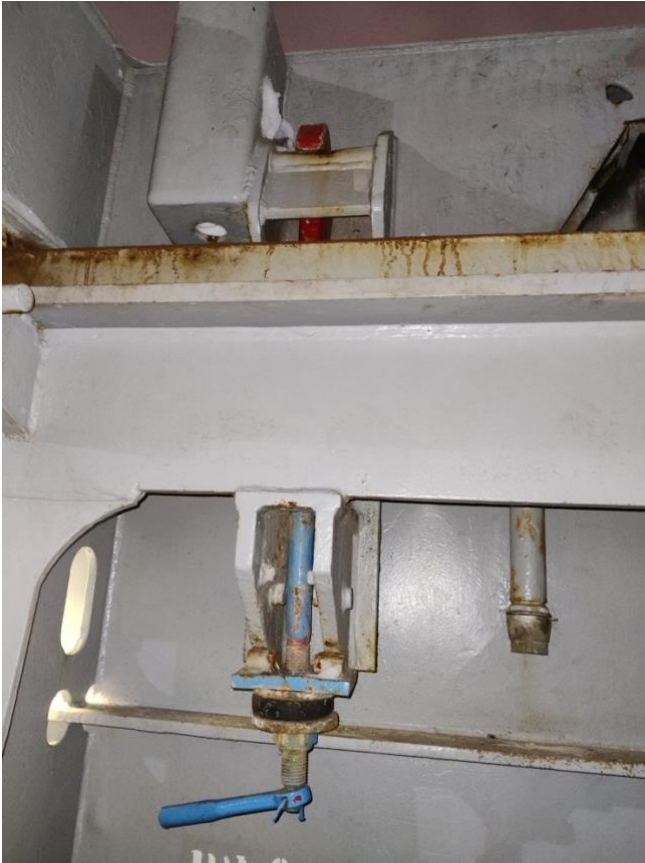
Figure 36 Quick acting cleat closed position. (Matti Heinonen 2021)

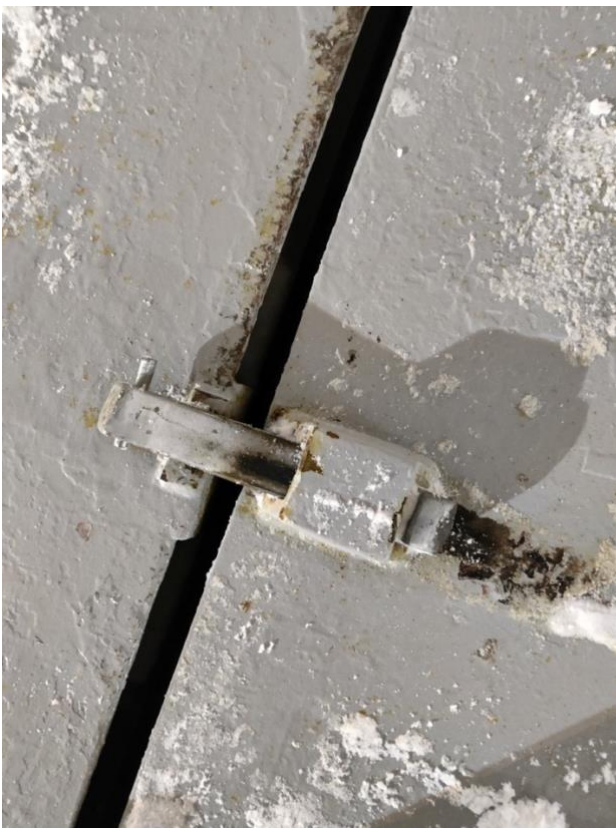
Figure 37 Cross-joint cleat close position. (Matti Heinonen 2021)
