Futuro no. 001 –

documentation and evaluation of preservation needs

Conservation
Historical Interiors
Bachelor's Thesis
28.5.2010

Anna-Maija Kuitunen

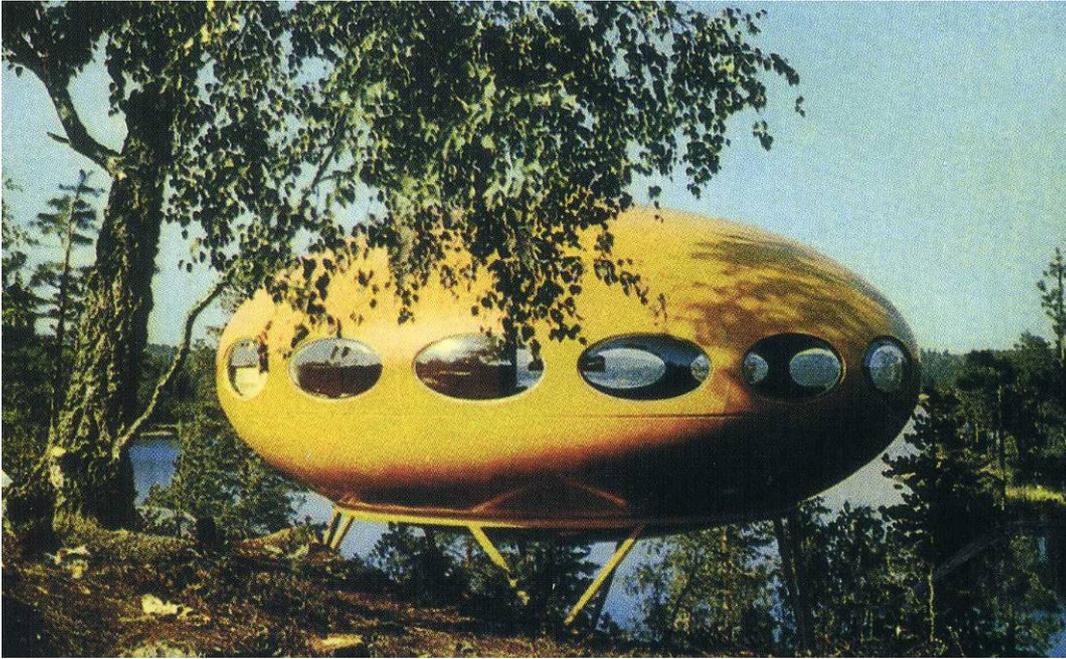
Figure 21. Futuro house stands close to the lake on a steep slope. Trees were cut down by the time of assembly in 1968. (Home & Taanila 2004)

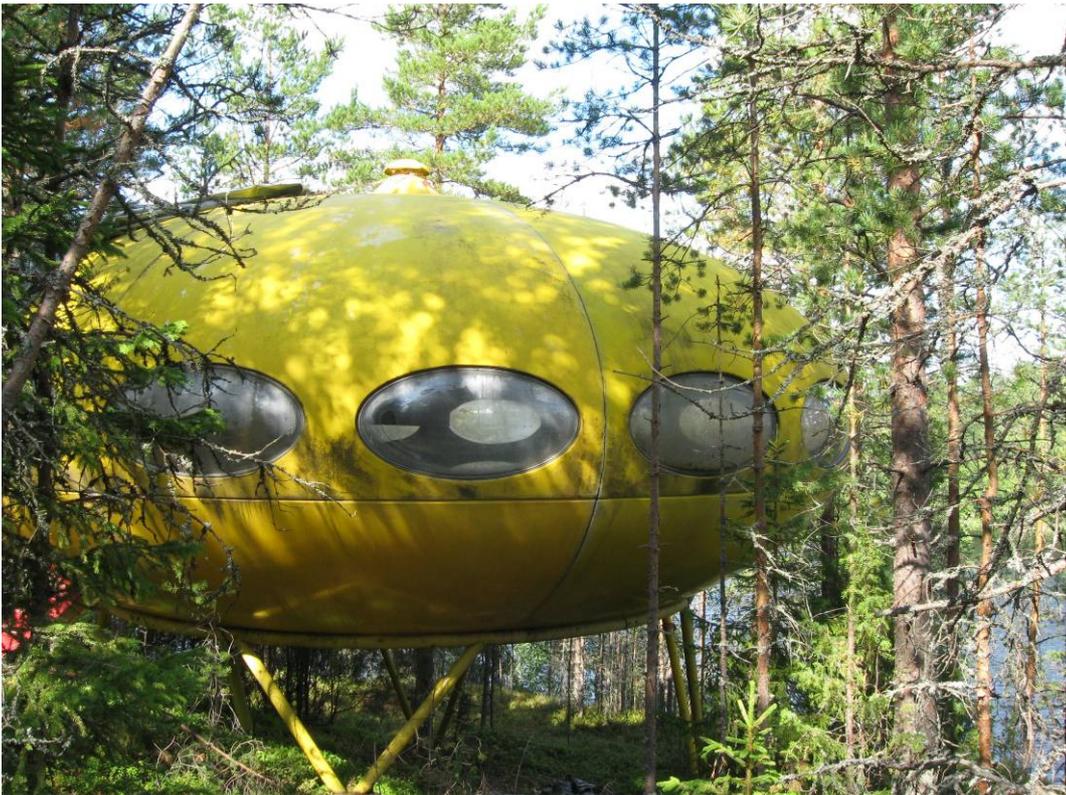
Figure 22. Today some of the trees grow quite close to the house.

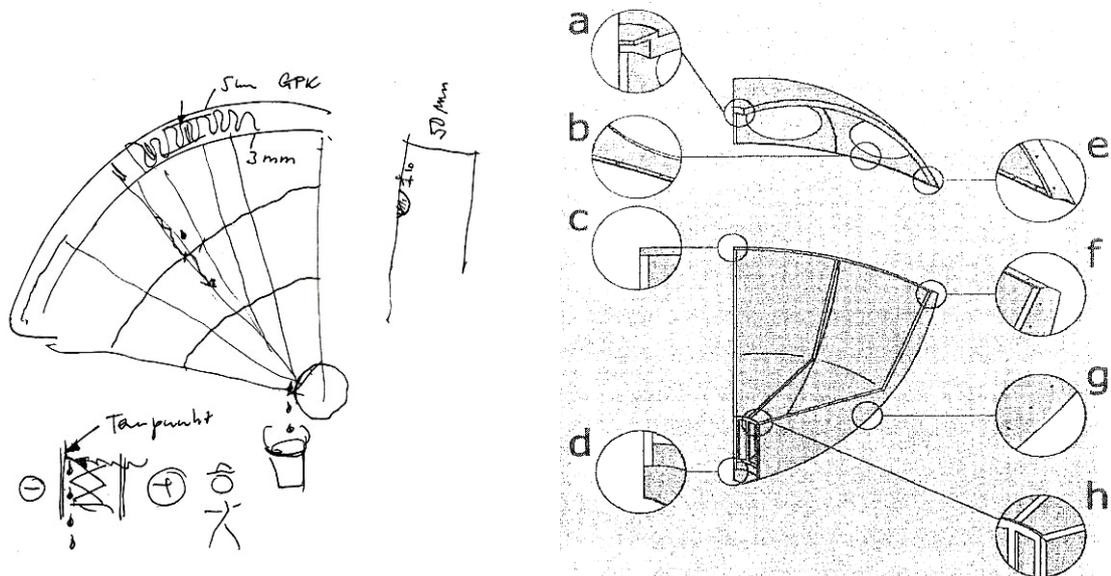
Figure 24. (left) Sketch of how condensed water passes down the structure by Suuronen. (Genzel & Voigt 2005)

According to the intention of architect Suuronen, the condensed water was aimed to slide down the convex inner surface and come out through the opening and probably through the small holes in the bottom (fig. 24.). If that idea has worked, the water has not stood too long in the structures and may not have caused any bigger damages to the wooden supports or to the PUR foam. It could be assumed that for example in spring time in Finland, the melting snow on top of the roof enters the structures through the cracked gaskets and freezes during the still cold nights. Water and ice may cause stress to the structure. The GRP plastics have a good resistance to water and weathering according to Waentig (2008, 261–263). Their aging characteristics are known to be good among all polymers. As every material they also have their limits but it is hard to find any uniform aging behavior within

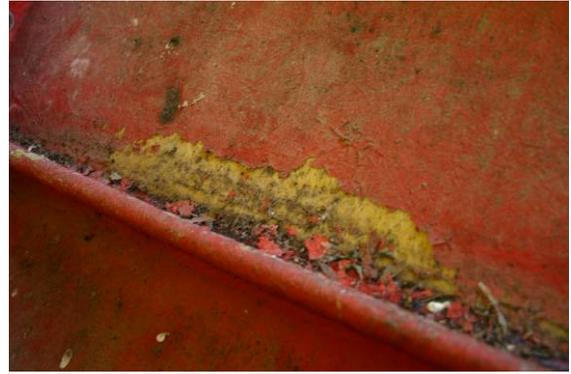
Figure 103. Red paint layer is coming off and gel-coat is exposed.

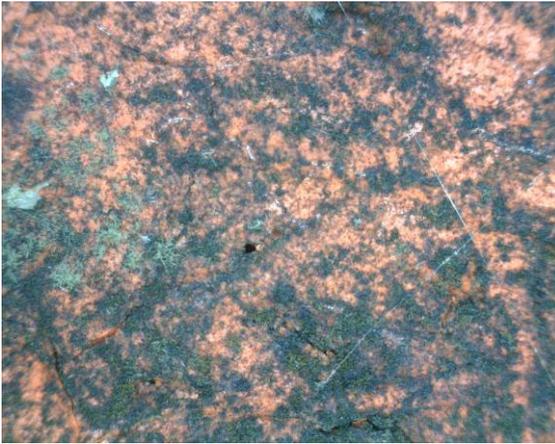
The exterior wall surface from the inside is covered by some black deposit (fig. 102. & 104.). A closer look reveals that the dirt has settled in the small hollows between the exposed glass fibres that can be seen in figure 105. The small dirt particles seem to be loose and easily removed mechanically. At some areas the deposit consists also of moss and algae growth. The dirt on the interior wall surface collects humidity and offers a good ground for micro-organism growth now and in the future if the dirt is not removed. The strongest moss growth was detected under the windows on some of the bolted edges where the roof and the floor elements encounter (fig. 107.). On these edges lay also dead insects. Only a few small areas of mechanical damages on the wall surfaces were detected. In these areas fine cracks are formed and the cracks have turned dark probably due to the moist and dirt penetration inside the cracks.

Figure 104. (left) The interior wall surface is covered by black deposit and with biological growth like moss. (60-fold magnification)

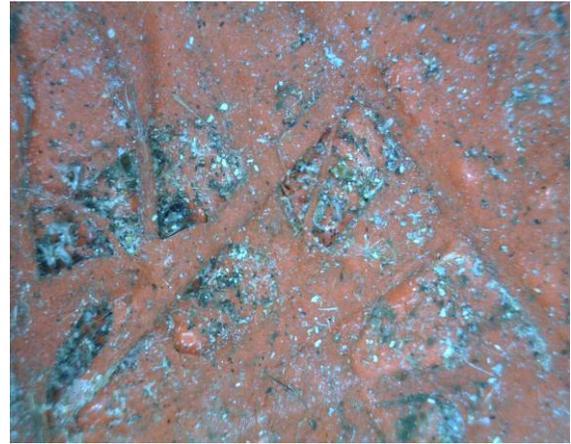
Figure 105. (right) The black and whitish deposits on the interior wall surface. The deposits stay easily on the out showing glass fibre. (200-fold magnification)

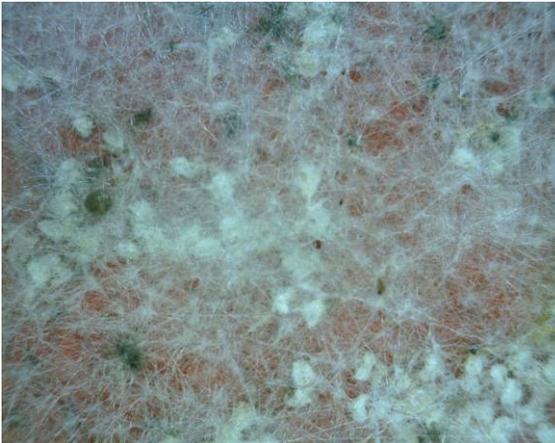
Figure 106. (left) White spots turned out to be spider nets. (60-fold magnification)

Some white spots were detected overall the interior wall surfaces. First, they were considered to be mould but a closer look exposed that they were spider nets. It seemed like there were a punch of spider eggs laid in the surface and covered with a net structure (fig. 106.). A further investigation revealed many dead spiders hanging in the ceiling. Other whitish dirt is the traces left by trickle water running down the dirty surfaces. When the water evaporates the dirt stays in the surface. On some places on the walls there are some whitish bird faeces.

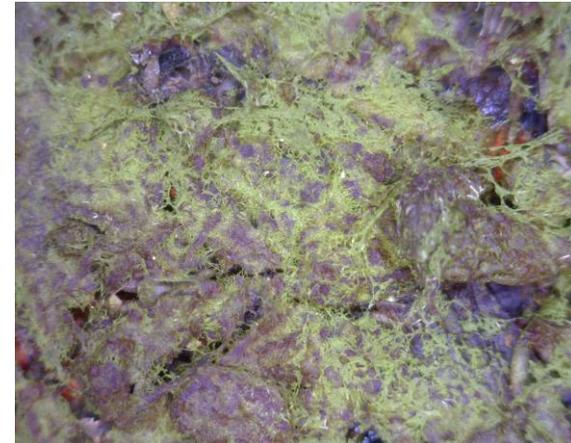
Figure 107. (right) Moss growth on the top of the bolted edge where the roof and the floor elements encounter. (200-fold magnification)

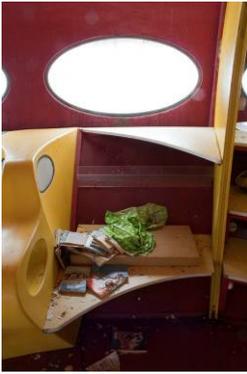
Figure 117. (left) Cushion on top of the shelf in the living room.

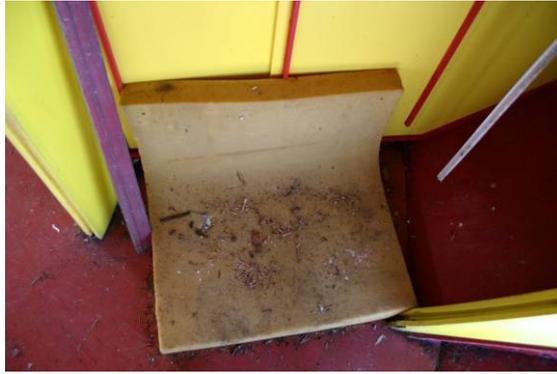
Figure 118. (middle) Cushion on the kitchenette floor.

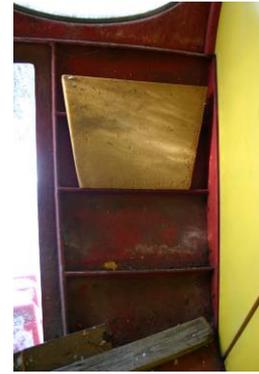
Figure 119. (right) Cushion in the entrance hall.

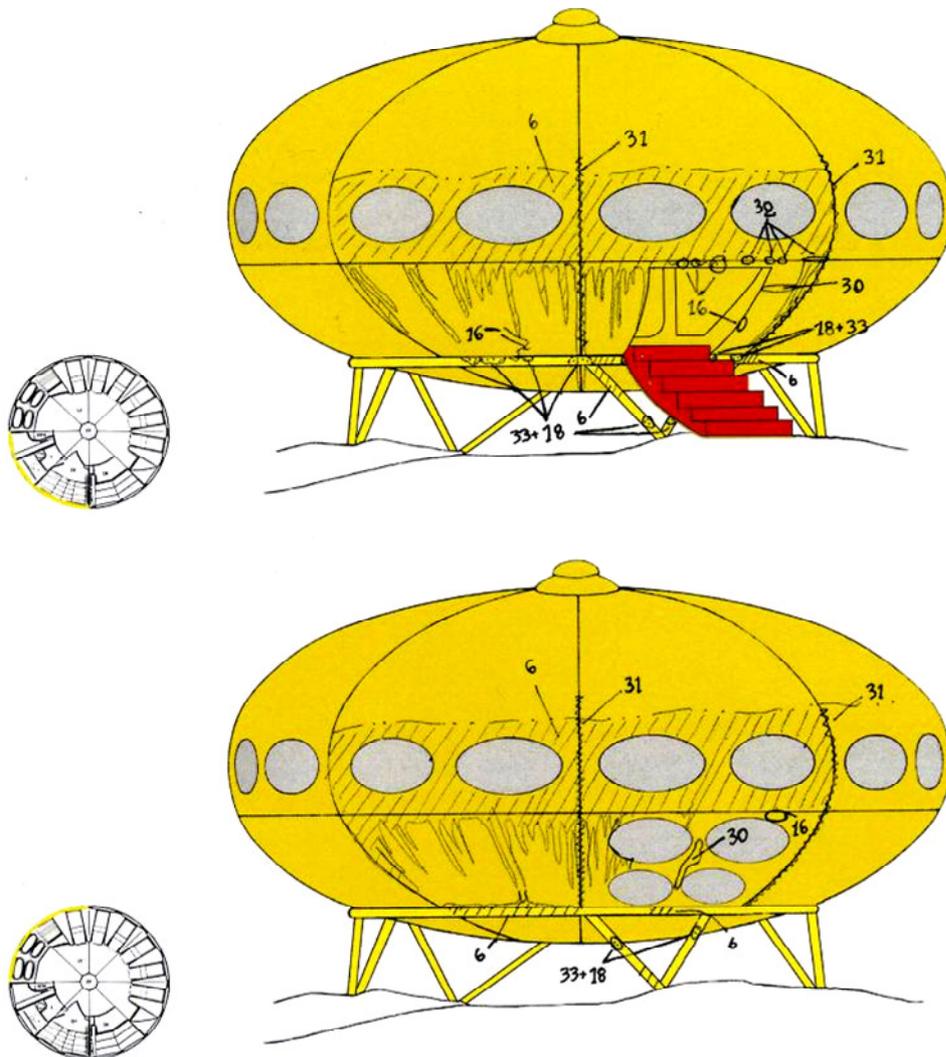
APPENDIX 1 – DAMAGE MAPPING OF EXTERIOR SURFACES

The surface of the steel legs is very dirty in some places (fig. 90.). The paint layer of the steel legs is coming off at some parts and rusted steel is shown (fig. 91.). Some screws are missing, which fasten the body of the house to the steel ring. Over one third of them are missing. The metal of the screws might have corroded and the screws may have fallen down. It is also possible that the steel legs have moved so much that the screws have loosened and fallen down. Detailed places of the damages are illustrated in the damage mapping (app. 1–3).

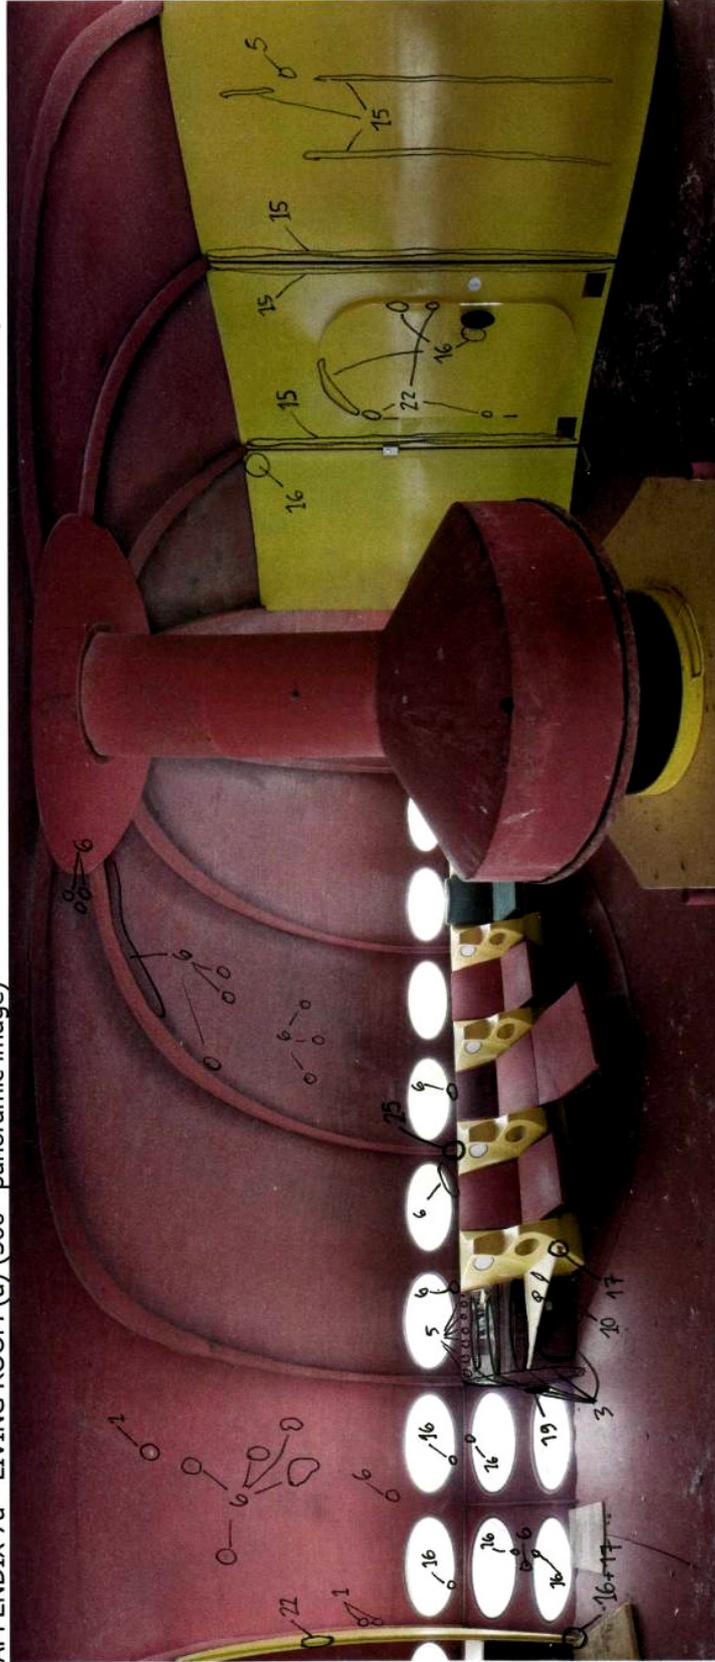
APPENDIX 7a - LIVING ROOM (a) (360° panoramic image)

The bed-chairs are all functioning in the way they were intended. The gel-coat finishing of the GRP armrests have been damaged at the level of the seats due to mechanical stress. The seat edges have hit the gel-coat surface when they have been pulled down. Some of the edges of the light switch openings in the armrests have damaged as well but are filled with a yellow putty. It is not known why and when the damages have emerged (Kuusla, interview 25.3.2010). These damages may have come up already at the time of assembly but fixed straight away so that they would not stick out. Two of the bed-chair upholsteries are not in their places but they are stored by the owner (Kuusla, interview 25.3.2010). The fabric of one padding has been torn out and its three different sized cushions lay all over the house. One cushion lays on the kitchenette floor, the second lays on one of the shelves in the living room and the third leans against the entrance hall's exterior wall (fig. 117.–119.). The paddings of the other bed-chairs are intact but the fabric has been torn a little. Some pieces of the edging strip of the shelves are missing (fig. 120.). Both gratings of the ventilation holes both side the living room door are detached and loose (fig. 121.). One of them is broken in two pieces. Detailed places of all of the damages in the living room are illustrated in the damage mapping (app. 7a, 7b & 9).

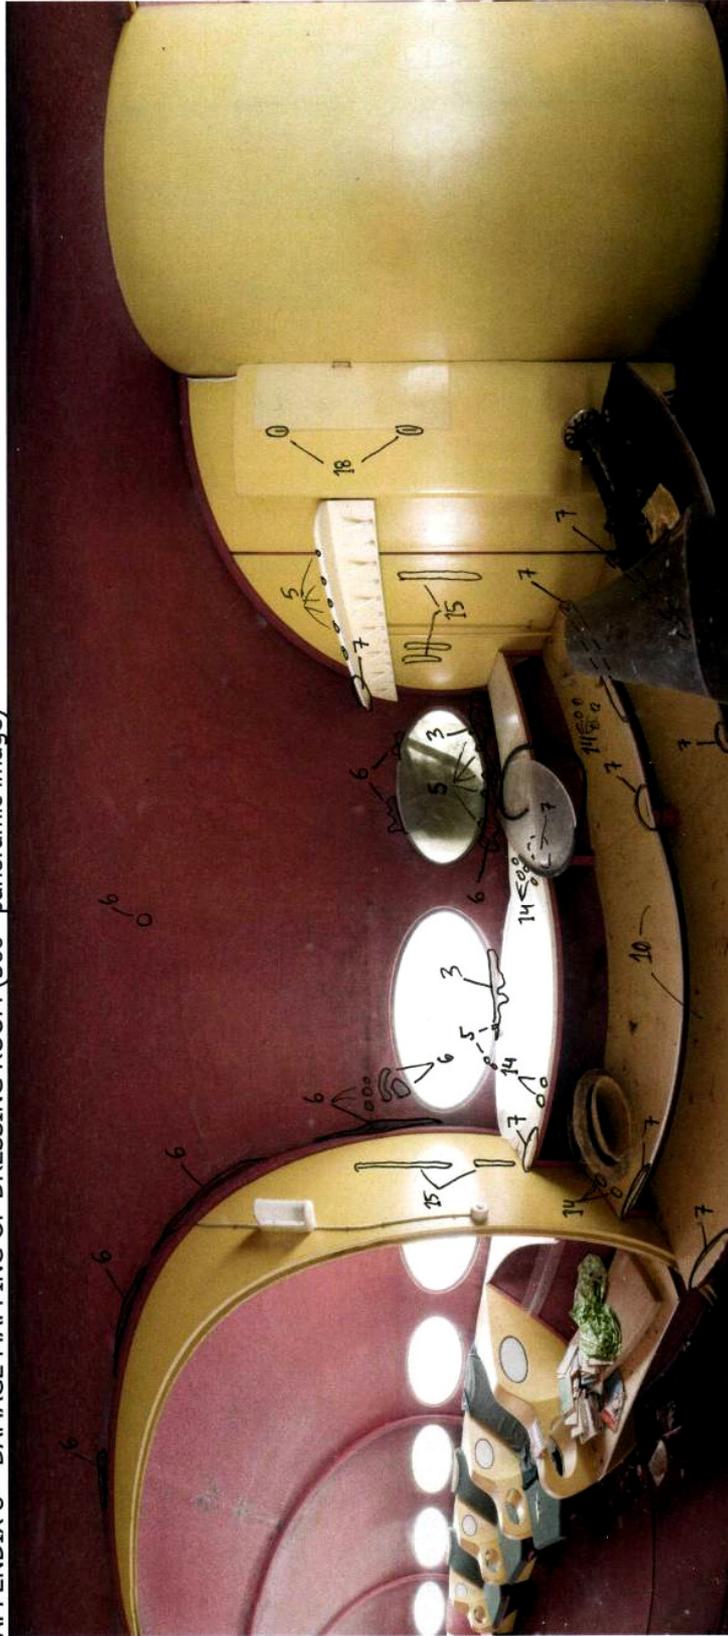
APPENDIX 8 – DAMAGE MAPPING OF DRESSING ROOM (360° panoramic image)

There are several dead spiders hanging on the dressing room ceiling. The shelves in the dressing room seem to have the same deterioration process going on. There are a few strips of the plastic edges loose and deformed so that they look like waves. Soon the moisture might penetrate inside the mixed veneer sheets and cause further damage. The right shelf leg at the floor level has white mould growth on it. The main circuit breaker in the corner has rusty hinges. Detailed places of all of the damages of the dressing room are illustrated in the damage mapping (app. 8).

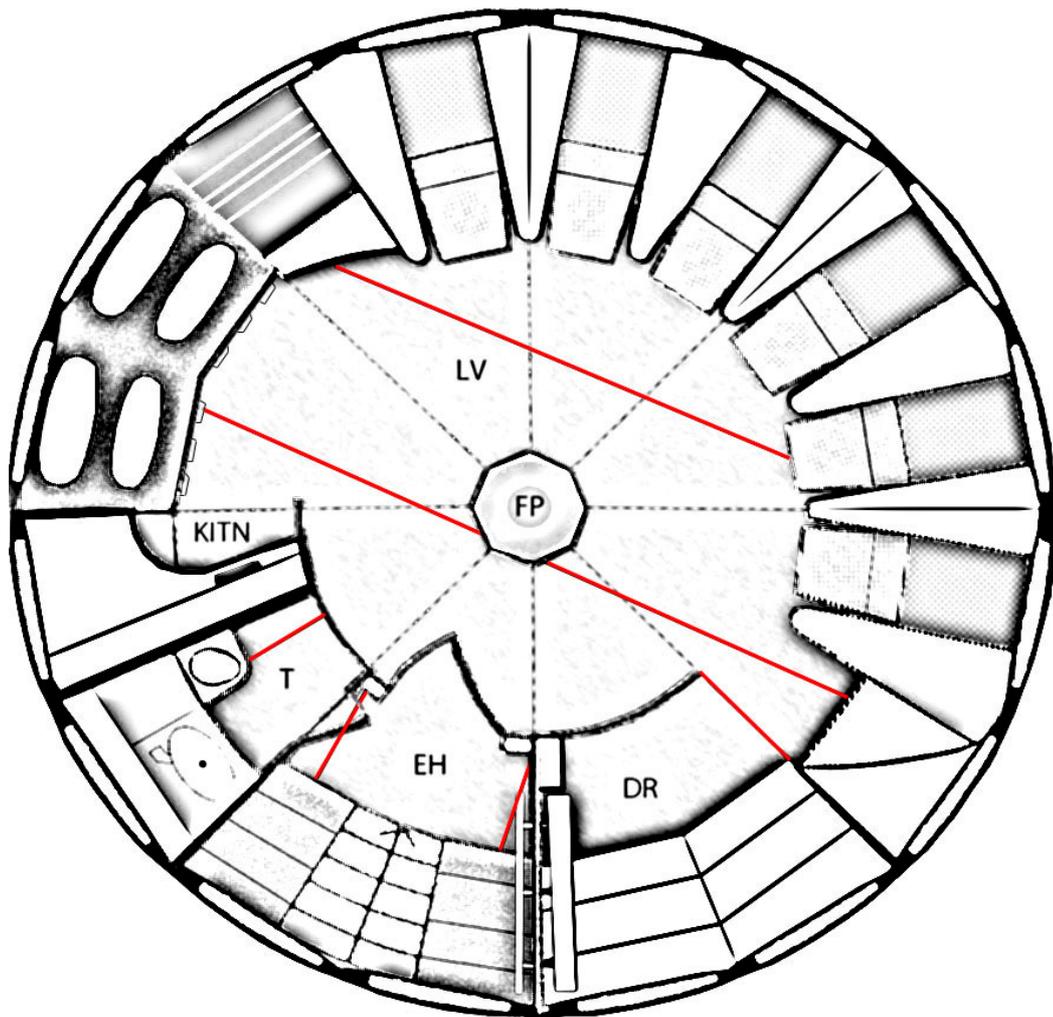
APPENDIX 10 – BORDERS OF THE CARPETS

The plywood floor deck under the adhered plastic carpet was not investigated by removing the carpet. Removing the carpet from the adhesion would have damaged the carpet. Nevertheless, the plywood floors seemed not be fragile. The opening and the small holes below the house probably guarantees an air flow under the floor deck that would keep it dry. The plastic carpet is in quite good condition. It is untidy due to the dust and dry leaves that have come into the house (fig. 44. & 45.). The floor has been wiped every now and then. The plastic carpet is adhered from several precisely cut pieces. Some of the carpet edges have come up probably due to the adhesive having lost its adhesion. Carpet pieces are illustrated in appendix 10.
